CENTRAL TEXAS TURNPIKE SYSTEM 2002 PROJECT

ANNUAL INSPECTION REPORT
FISCAL YEAR 2011

Subject: FY 2011 Inspection of the Central Texas Turnpike System, 2002 Project

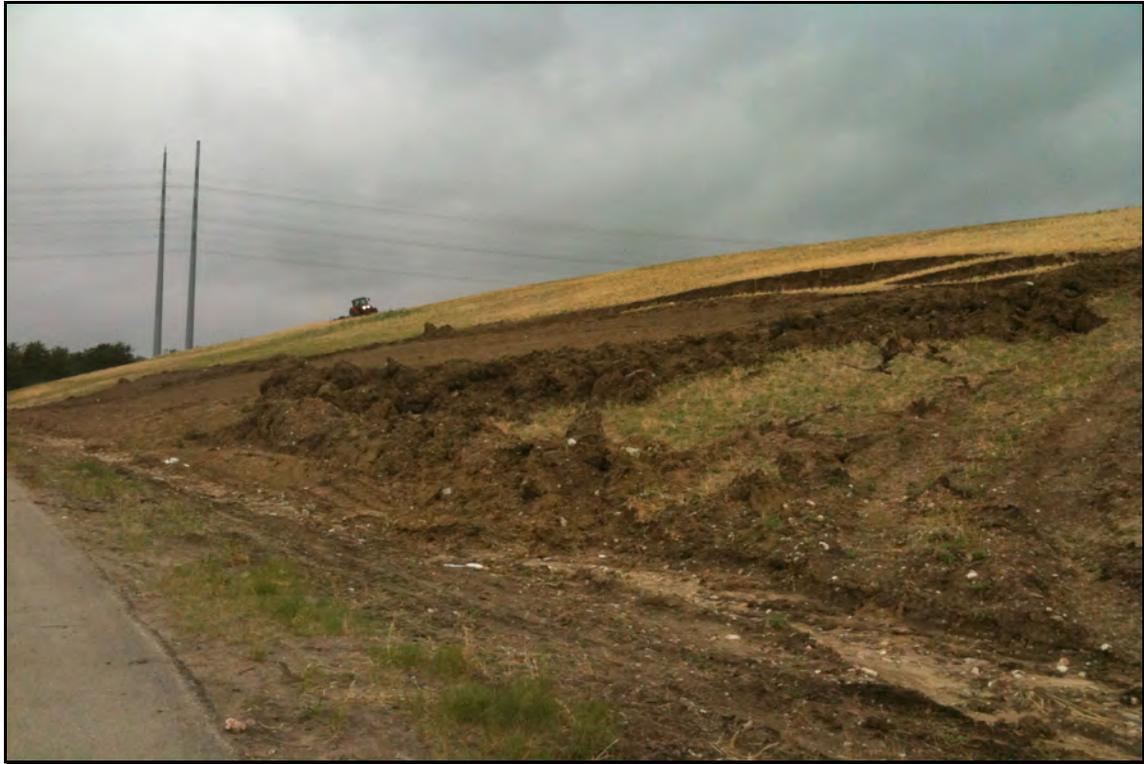
Figure 5 – Deteriorated Shoulder and Turf Condition

The determination of the Roadside score for roadside features is generally based upon the consideration of vegetation management, litter removal, drainage structures, and other elements located outside of the paved travel way (Figure 2). The roadside category is in excellent condition and has achieved an overall score of 99. There were no characteristics that rated lower than 94. The lowest element, vegetation management, was found on SH 130. This score is an improvement from the Roadside score in FY 2010.

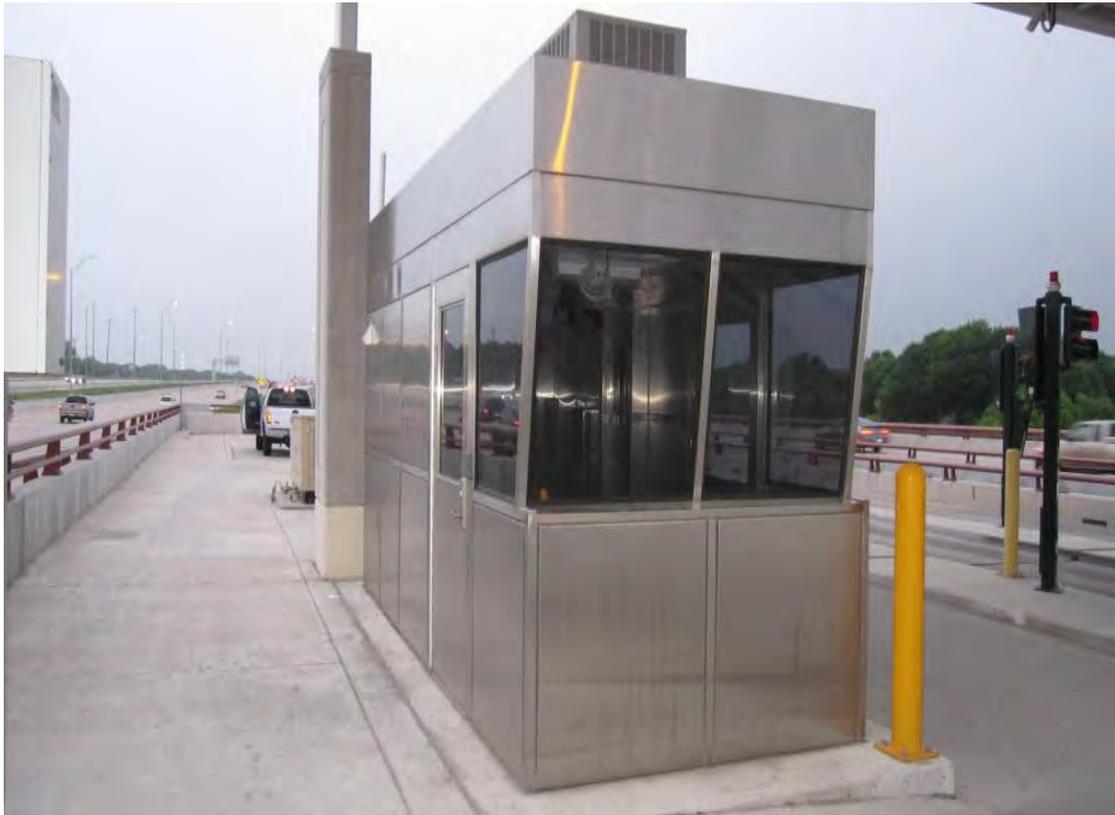
Figure 9 - Tollbooth

All tollbooths, including forty that have been decommissioned, were inspected during the FY 2011 inspection. Tollbooths and related subcomponents were noted in excellent condition throughout the CTTS. A typical tollbooth configuration is pictured below in Figure 9. The condition of the elements and the corresponding deficiencies for each of these categories is summarized in Tables 9 through 11, with a system-wide summary shown in Table 12.

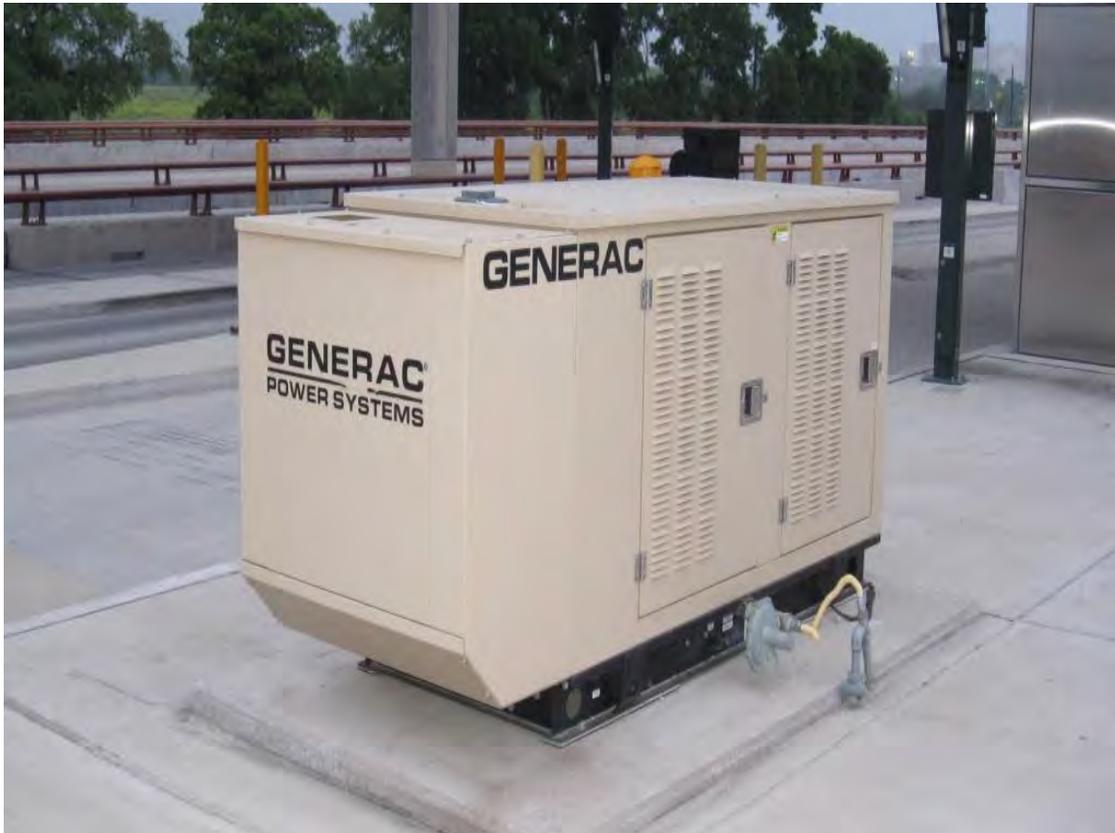
Figure 10 – Facility Generator

Of the 895 total elements in the electrical category, only twelve elements were noted as deficient for an overall deficiency rate of 1.34%. A majority of the deficient elements were non-functioning GFI receptacles located throughout the system. No generators were found to be deficient.

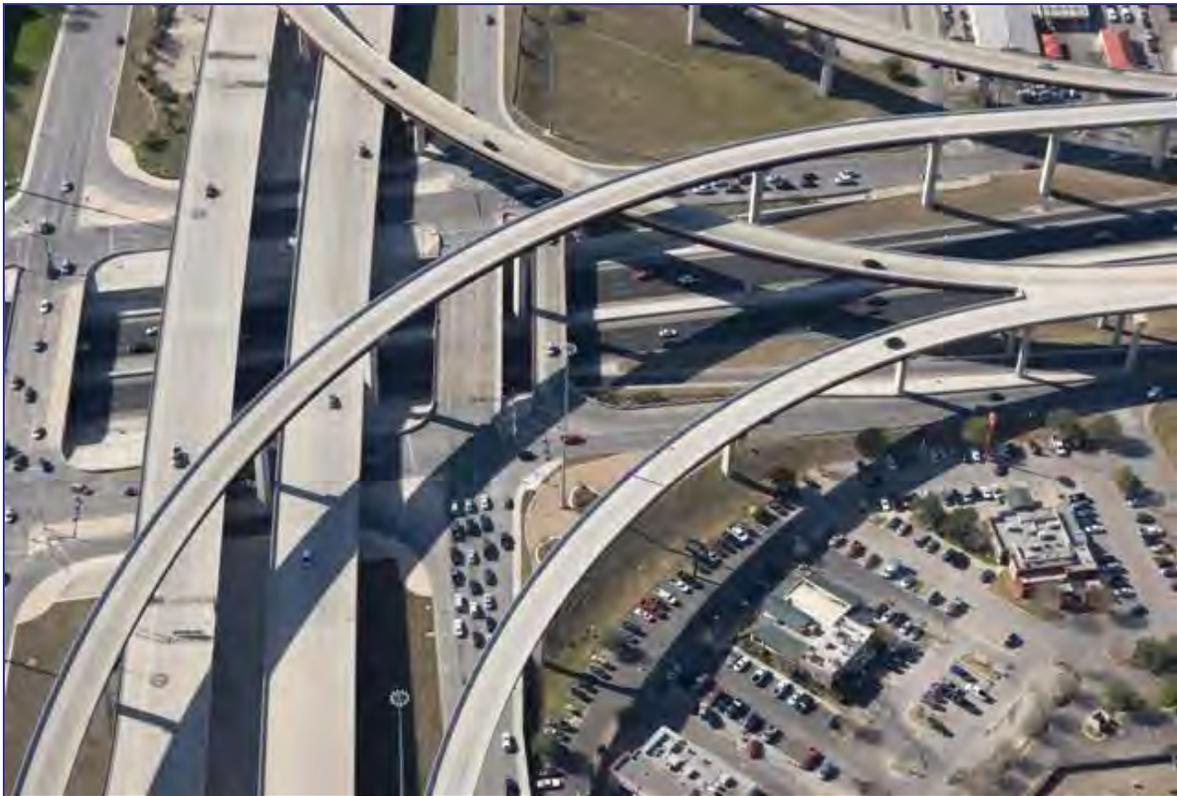
Figure 11 - Bridges

The Federal Bridge Inspection Summary Report (Appendix C) was compiled, reviewed, and is included on the CD located in the CD jacket inside the back cover of this report. The bridge components and major elements are listed in Table 14. The biennial inspection is based on three main components, comprised of a total of 93 elements and 117 sub-elements for fixed bridges only. A numerical score is generated for each component based on the rating scale shown in Table 15. All of the CTTS's bridges were inspected in FY 2010 and the results are included in this report. The next inspection of the bridges is scheduled for FY 2012. A review of the Federal Bridge Inspection Summary Report found no major deficiencies on any bridge within the CTTS. Of the 210 bridges within the CTTS only 5 (2.4%) had a rating in any category as low as 6 (Satisfactory). The remainder of the ratings were all in the 7 to 9 range (Good to Excellent).

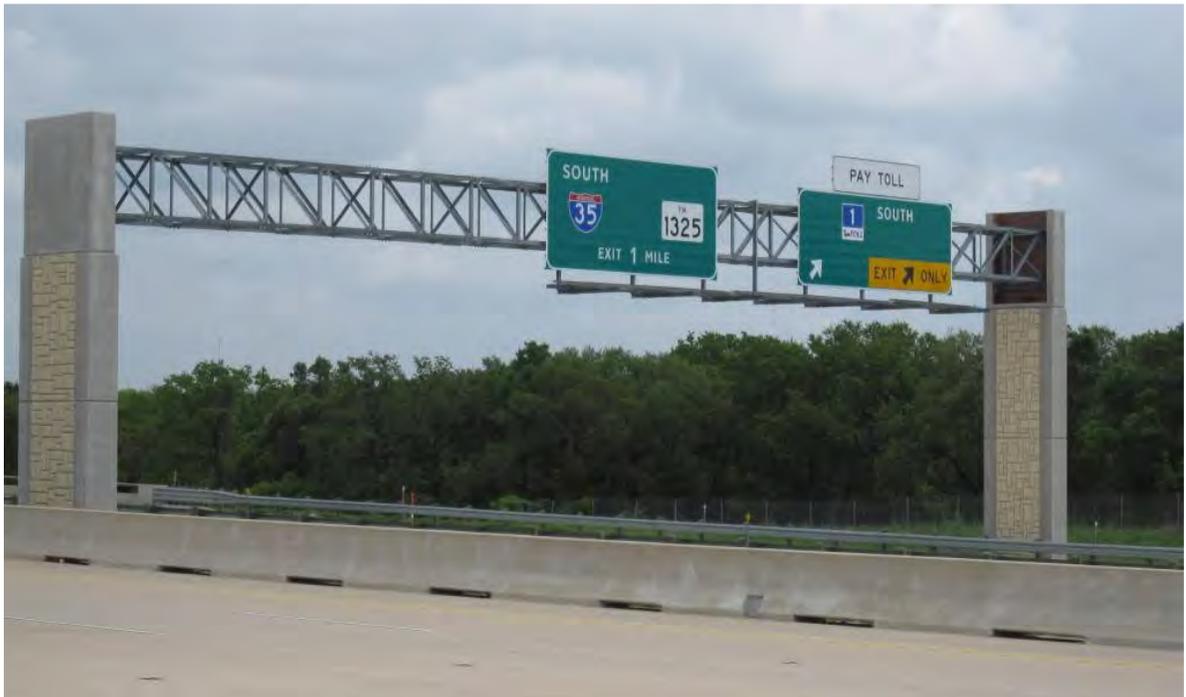
Figure 12 - Overhead Sign Structure

Overhead and cantilever signs, such as the one pictured in Figure 12, are suspended above the travel way by large support structures and are included in the roadside category. These signs provide critical directional information, guiding the patron throughout the Central Texas Turnpike System. TxDOT performed an inspection of the overhead/cantilever structures at the completion of their construction. At that time, none of the overhead/cantilever sign components and subcomponents inspected was noted as being in less than fair condition. Beginning in FY 2011, the overhead and cantilever signs will be inspected biennially. In FY 2011, the overhead and cantilever signs for SH 45 were inspected. Next year, the overhead and cantilever signs for Loop 1 and SH 130 will be inspected. The results of this year's inspection indicate that SH 45's 75 overhead and cantilever signs are in very good condition. A total of 5 items were found to be in need of repair. These items have been reported to Austin District Maintenance. A summary of the results and the items in need of repair can be found in Appendix D.

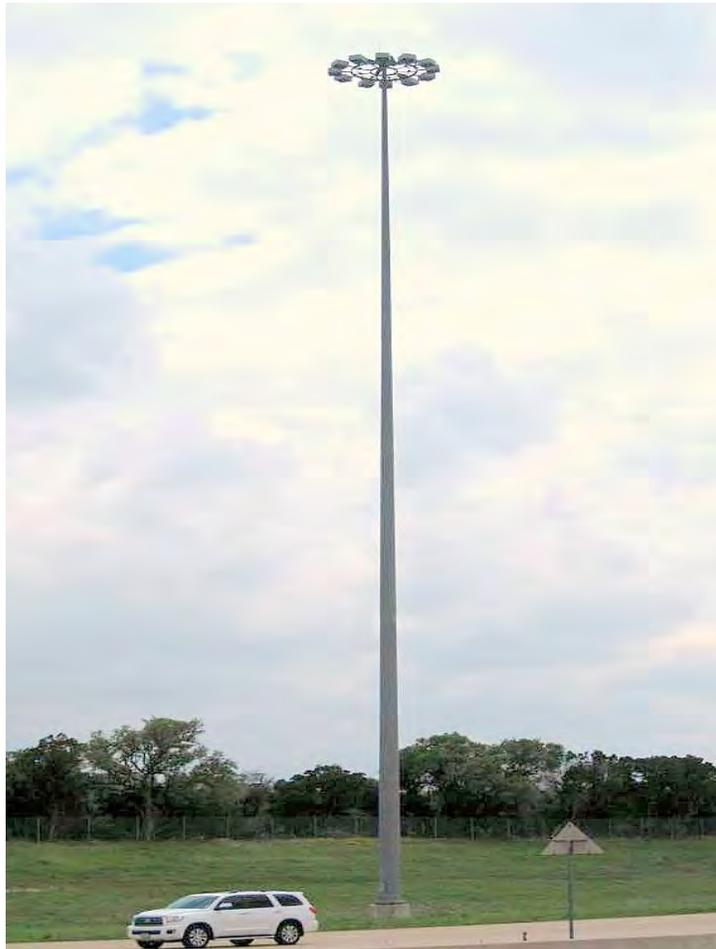
Figure 13 – High Mast Light Tower

Similar to overhead/cantilever signs, HMLTs were inspected by TxDOT at the completion of their construction. No deficiencies were noted during the post construction inspection. These structures, like the one pictured in Figure 13, provide illumination for improved nighttime visibility at various locations along the CTTS, such as interchanges and toll facilities. The condition of high mast light towers is determined by the two components listed in Table 17 below. Beginning in FY 2011, the HMLTs will be inspected biennially. In FY 2011, the HMLTs for SH 45 were inspected. Next year, the HMLTs for Loop 1 and SH 130 will be inspected. The results of this year's inspection indicate that SH 45's 61 HMLTs are in very good condition. A total of 16 minor deficiencies were found to be in need of repair. These items have been reported to Austin District Maintenance. A summary of the results and the items in need of repair can be found in Appendix D.
