CENTRAL TEXAS TURNPIKE PROJECT

ANNUAL INSPECTION REPORT
FISCAL YEAR 2010

PREPARED BY **PBSJ**[®]
GENERAL ENGINEERING CONSULTANT

Subject: FY 2010 Inspection of the Central Texas Turnpike Project

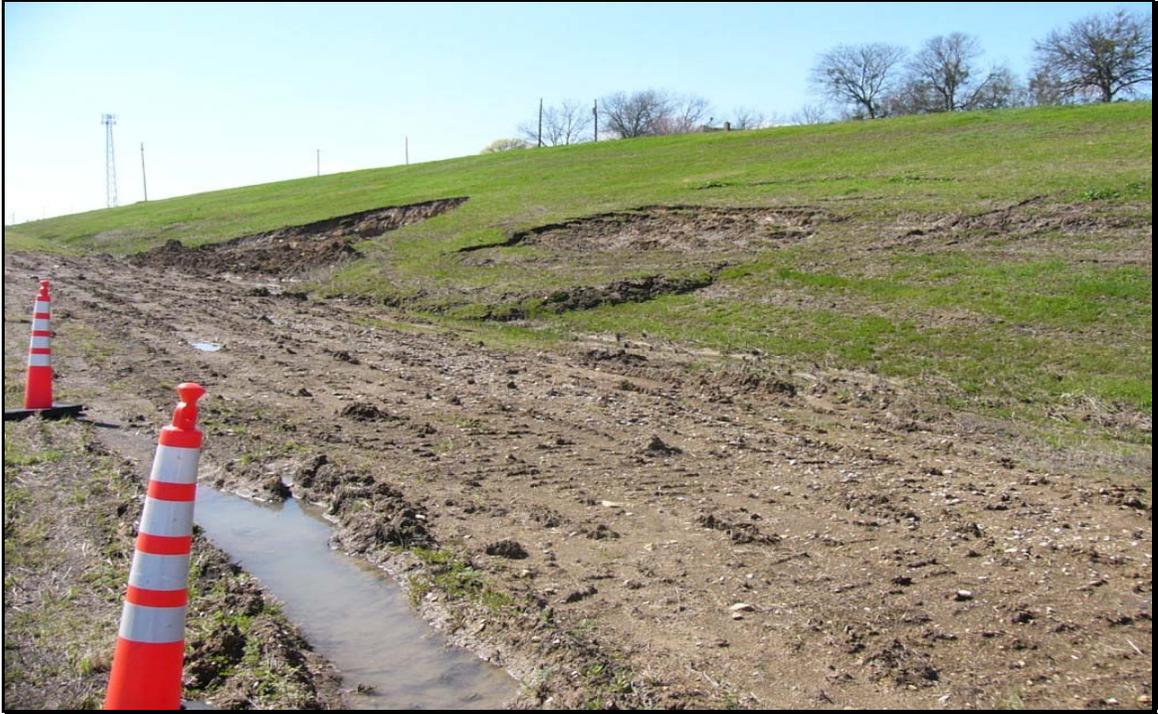
The determination of the Roadside score for roadside features is generally based upon the consideration of vegetation management, litter removal, drainage structures, and other elements located outside of the paved travel way (Figure 2). The roadside category is in excellent condition and has achieved an overall score of 97. There were no characteristics that rated lower than 86. The lowest element, vegetation management, was found on SH 130. A combination of sparse and/or missing turf in combination with minor erosion contributed to the reduced score. Some of the vegetation management issues may be attributed to the severe drought conditions present through the summer of 2009 that were quickly followed by intense rains.

Figure 5 – Deteriorated Shoulder and Turf Condition

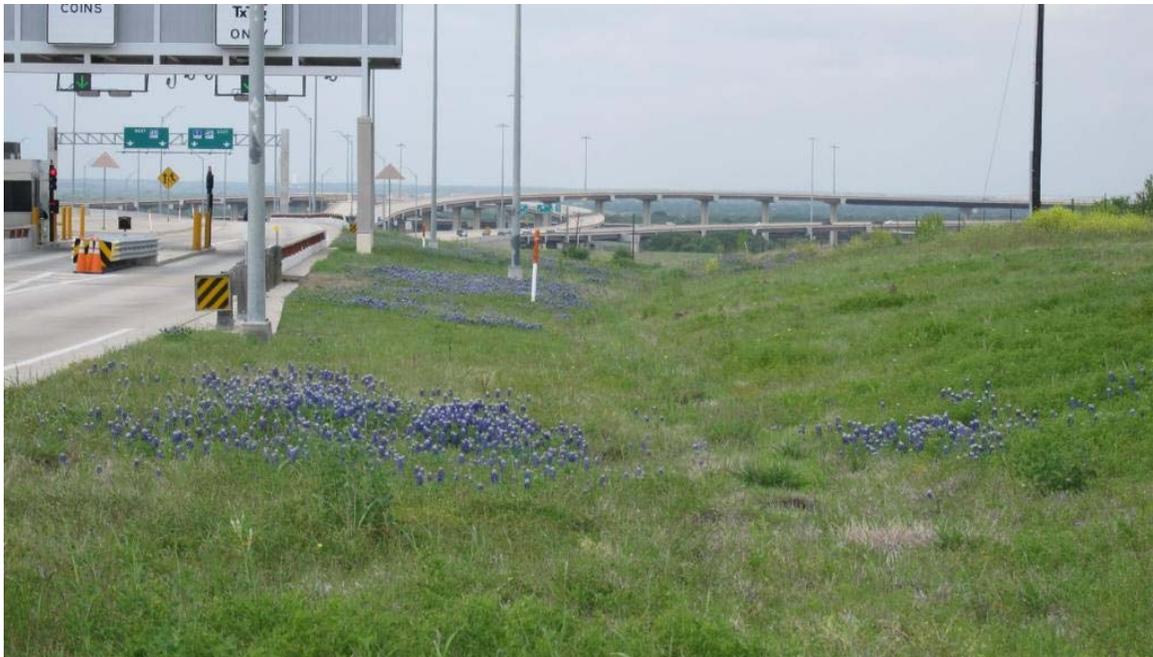
Figure 6 – Desired Shoulder and Turf Condition

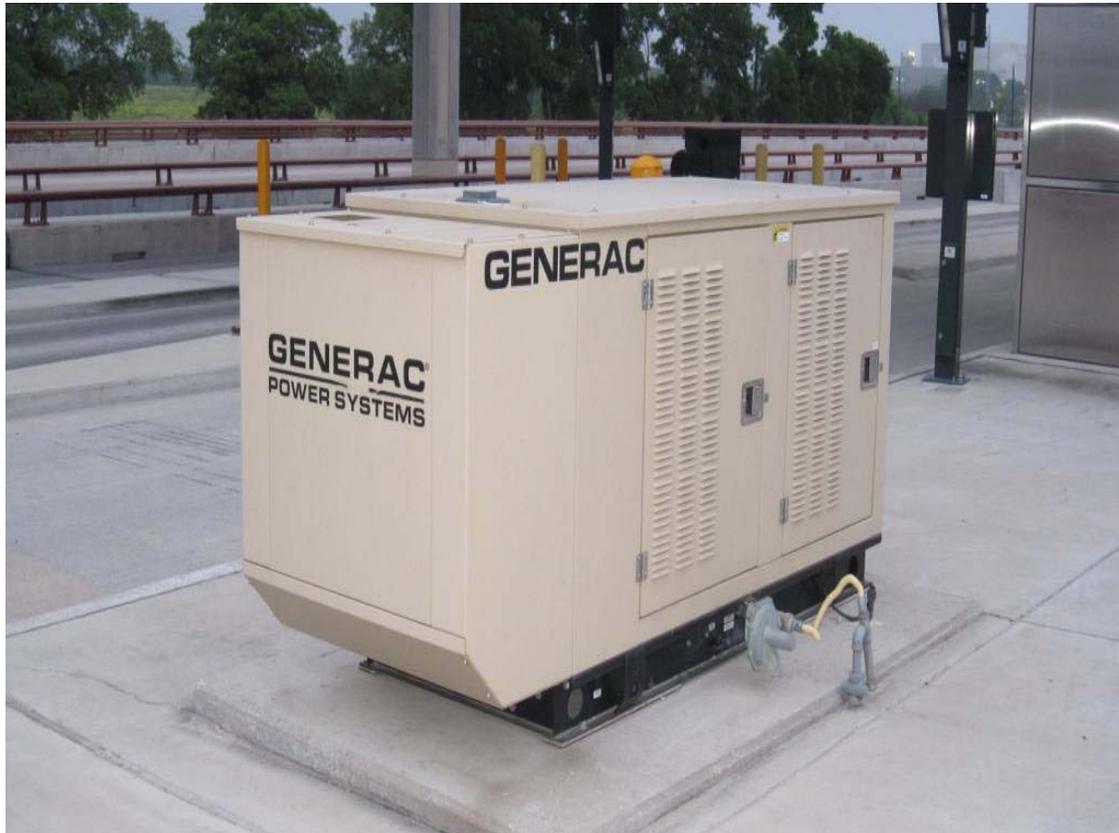
Of the 1298 total elements in the electrical category, only eleven elements were noted as deficient for an overall deficiency rate of 0.85%. Seven of the deficient elements are non-functioning GFI receptacles located at several facilities throughout the system. No generators were found to be deficient.

Figure 10 – Facility Generator

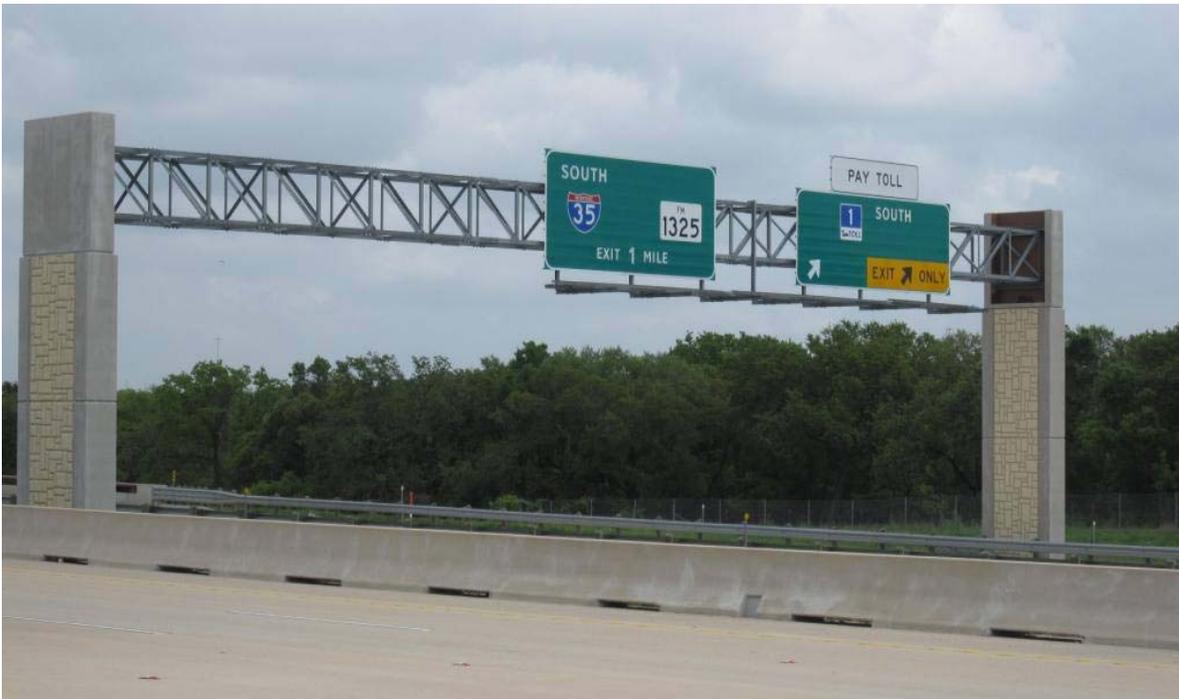
Overhead and cantilever signs, such as the one pictured in Figure 12, are suspended above the travel way by large support structures and are included in the roadside category. These signs provide critical directional information, guiding the patron throughout the Central Texas Turnpike Project. TxDOT performed an inspection of the overhead/cantilever structures at the completion of their construction. At that time, none of the overhead/cantilever sign components and subcomponents inspected was noted as being in less than fair condition. We recommend that TxDOT conduct a biennial inspection of the overhead/cantilever sign components included in the assessment as listed in Table 16 below. The standard five point TxCAP rating scale was utilized to assess the condition of all overhead/cantilever sign structures.

Figure 12 - Overhead Sign Structure

- Those elements identified as sub-standard should be addressed and returned to the proper level.
- TxDOT initiate an inspection program for overhead and cantilever sign components.
- TxDOT initiate an inspection program for high mast light towers.
- TxDOT should use the maintenance reserve funds to repair the Loop 1 pavement as noted.

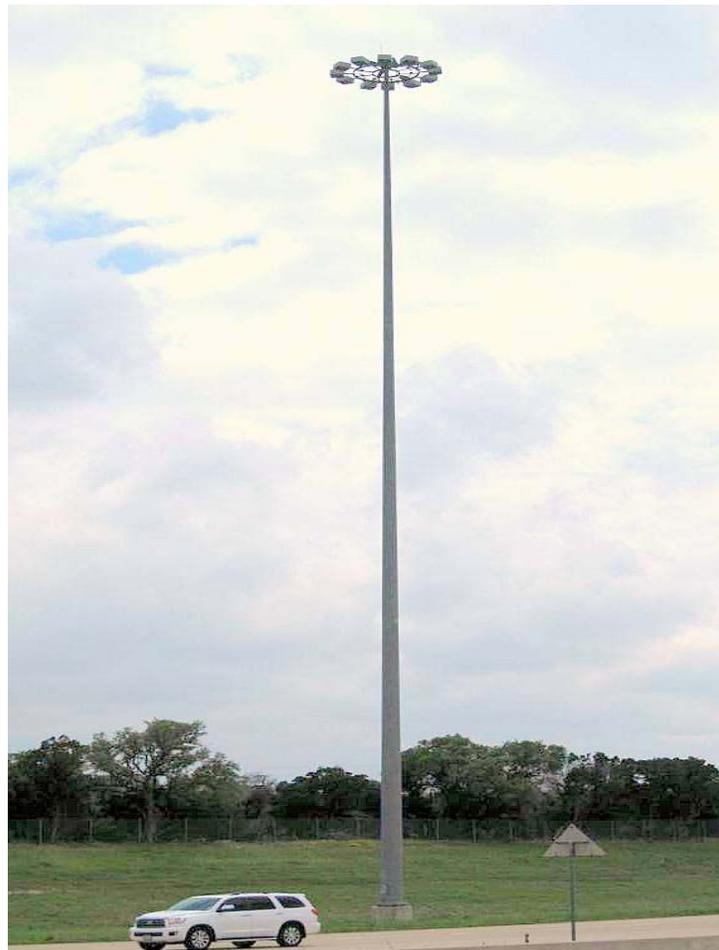
Similar to overhead/cantilever signs, HMLTs were inspected by TxDOT at the completion of their construction. No deficiencies were noted during the post construction inspection. These structures, like the one pictured in Figure 13, provide illumination for improved nighttime visibility at various locations along the CTTTP, such as interchanges and toll facilities. The condition of high mast light towers is determined by the two components listed in Table 17 below. We recommend that TxDOT conduct a biennial inspection of the structural components of the High Mast Light Towers.

Figure 13 – High Mast Light Tower
