# CENTRAL TEXAS TURNPIKE SYSTEM 2002 PROJECT

ANNUAL INSPECTION REPORT  
FISCAL YEAR 2011

Subject: FY 2011 Inspection of the Central Texas Turnpike System, 2002 Project

**Annual Inspection Report**  
For the fiscal Year ending August 31, 2011

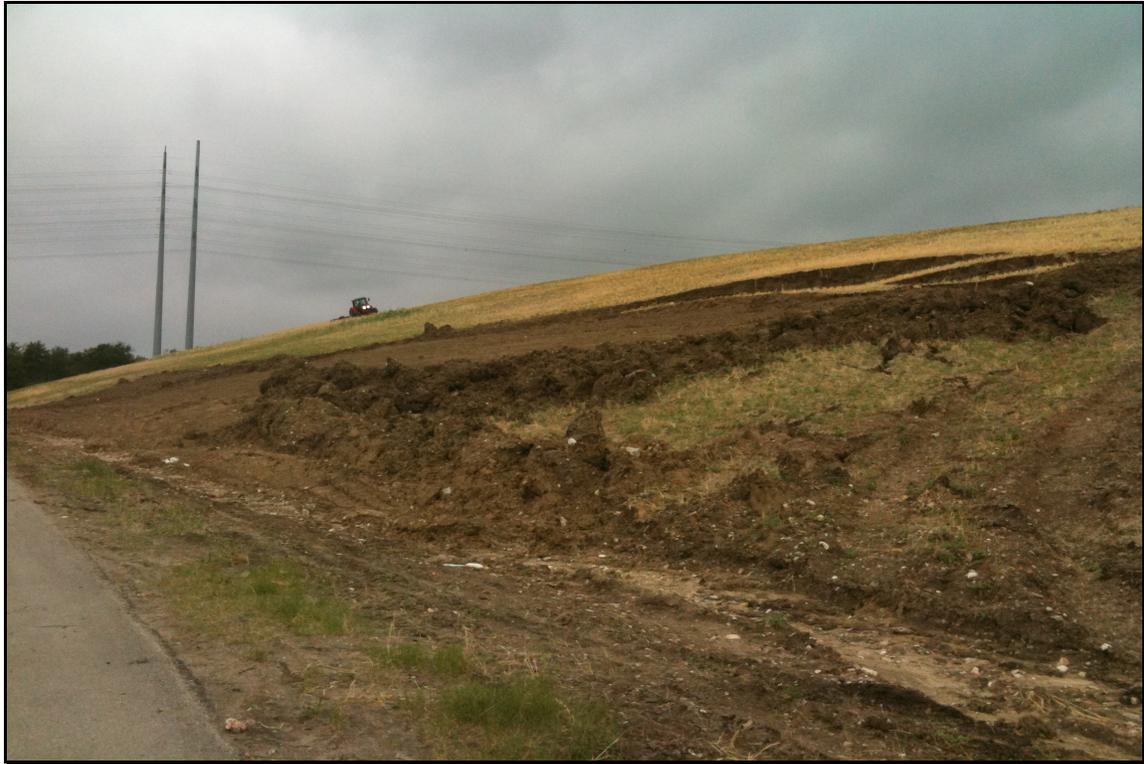
Figure 5 – Deteriorated Shoulder and Turf Condition

The determination of the Roadside score for roadside features is generally based upon the consideration of vegetation management, litter removal, drainage structures, and other elements located outside of the paved travel way (Figure 2). The roadside category is in excellent condition and has achieved an overall score of 99. There were no characteristics that rated lower than 94. The lowest element, vegetation management, was found on SH 130. This score is an improvement from the Roadside score in FY 2010.

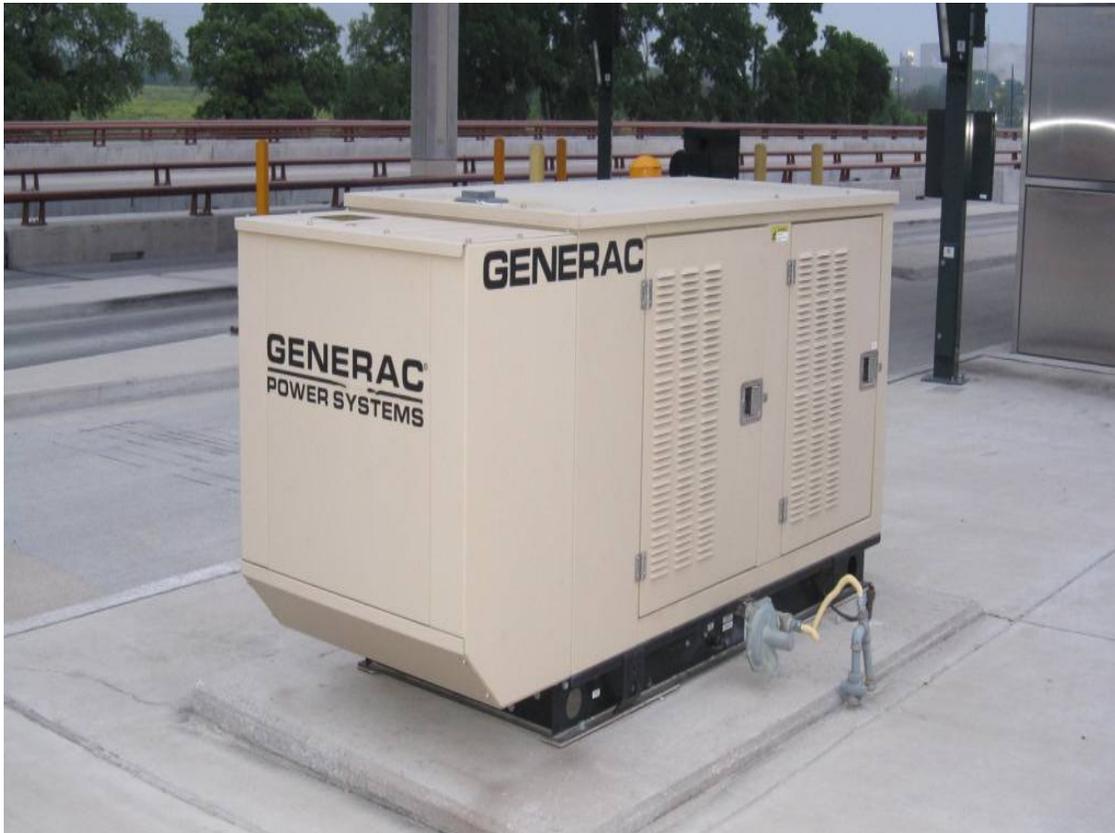
Figure 10 – Facility Generator

Of the 895 total elements in the electrical category, only twelve elements were noted as deficient for an overall deficiency rate of 1.34%. A majority of the deficient elements were non-functioning GFI receptacles located throughout the system. No generators were found to be deficient.

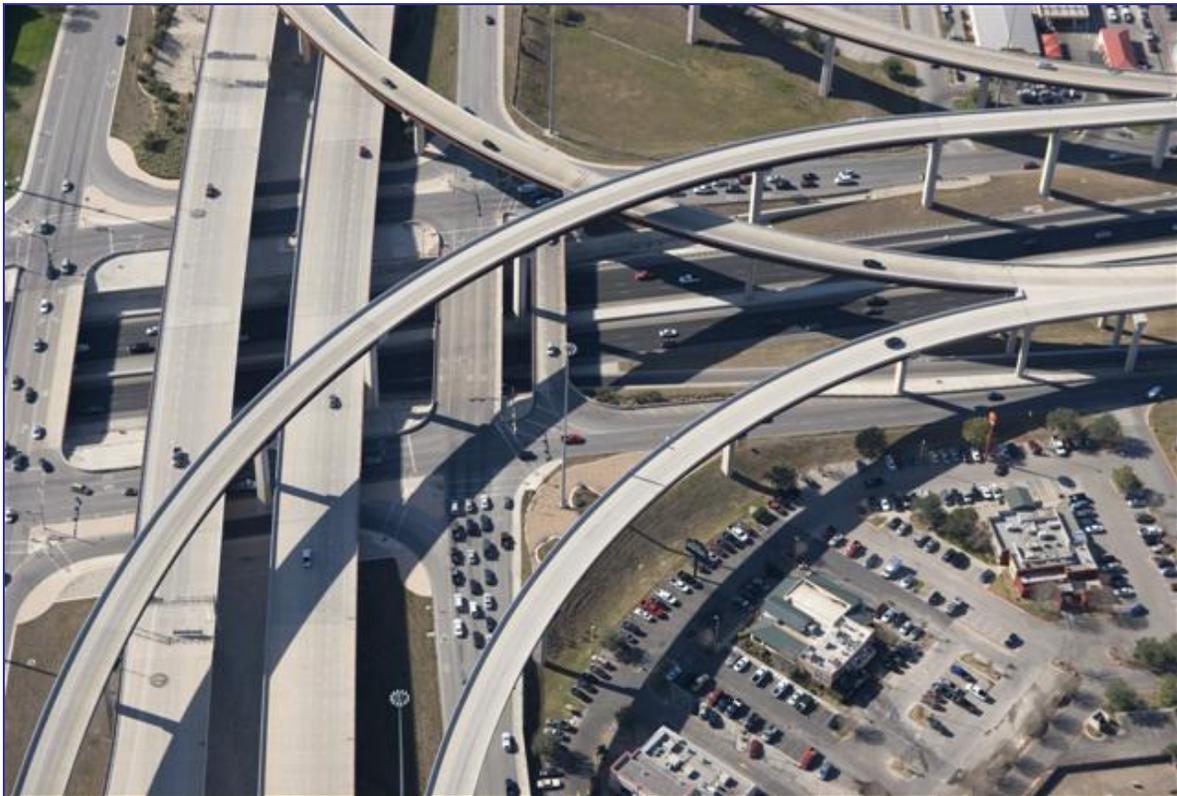
Figure 11 - Bridges

The Federal Bridge Inspection Summary Report (Appendix C) was compiled, reviewed, and is included on the CD located in the CD jacket inside the back cover of this report. The bridge components and major elements are listed in Table 14. The biennial inspection is based on three main components, comprised of a total of 93 elements and 117 sub-elements for fixed bridges only. A numerical score is generated for each component based on the rating scale shown in Table 15. All of the CTTS's bridges were inspected in FY 2010 and the results are included in this report. The next inspection of the bridges is scheduled for FY 2012. A review of the Federal Bridge Inspection Summary Report found no major deficiencies on any bridge within the CTTS. Of the 210 bridges within the CTTS only 5 (2.4%) had a rating in any category as low as 6 (Satisfactory). The remainder of the ratings were all in the 7 to 9 range (Good to Excellent).

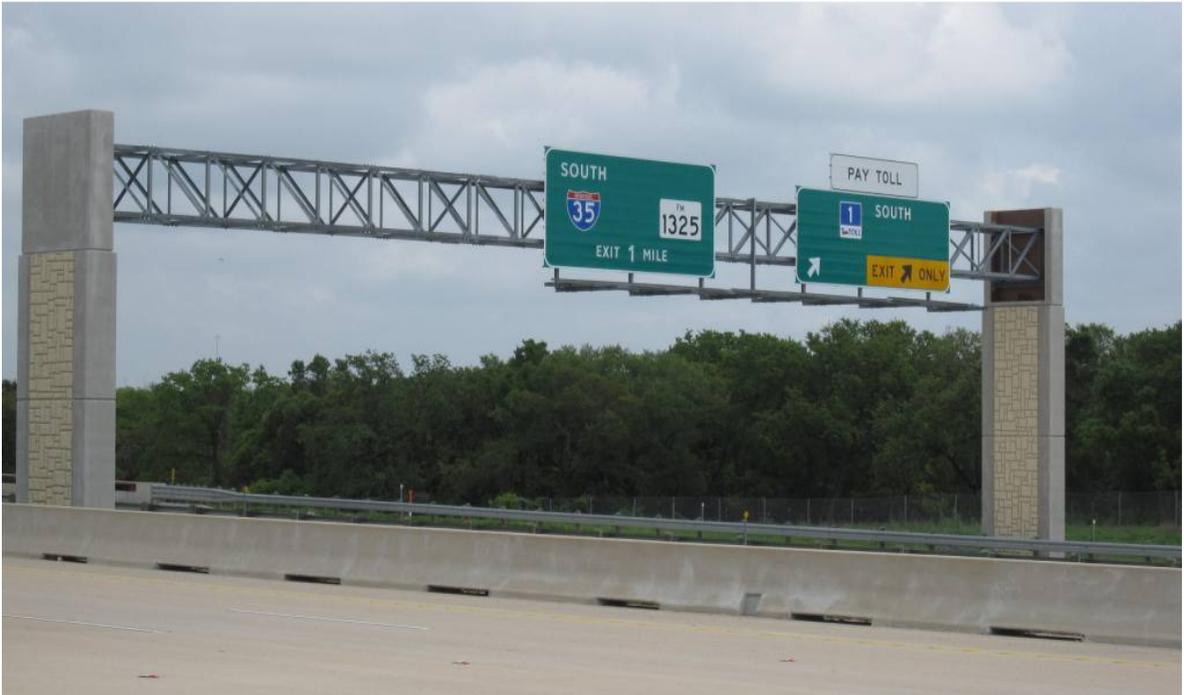
Figure 12 - Overhead Sign Structure

Overhead and cantilever signs, such as the one pictured in Figure 12, are suspended above the travel way by large support structures and are included in the roadside category. These signs provide critical directional information, guiding the patron throughout the Central Texas Turnpike System. TxDOT performed an inspection of the overhead/cantilever structures at the completion of their construction. At that time, none of the overhead/cantilever sign components and subcomponents inspected was noted as being in less than fair condition. Beginning in FY 2011, the overhead and cantilever signs will be inspected biennially. In FY 2011, the overhead and cantilever signs for SH 45 were inspected. Next year, the overhead and cantilever signs for Loop 1 and SH 130 will be inspected. The results of this year's inspection indicate that SH 45's 75 overhead and cantilever signs are in very good condition. A total of 5 items were found to be in need of repair. These items have been reported to Austin District Maintenance. A summary of the results and the items in need of repair can be found in Appendix D.

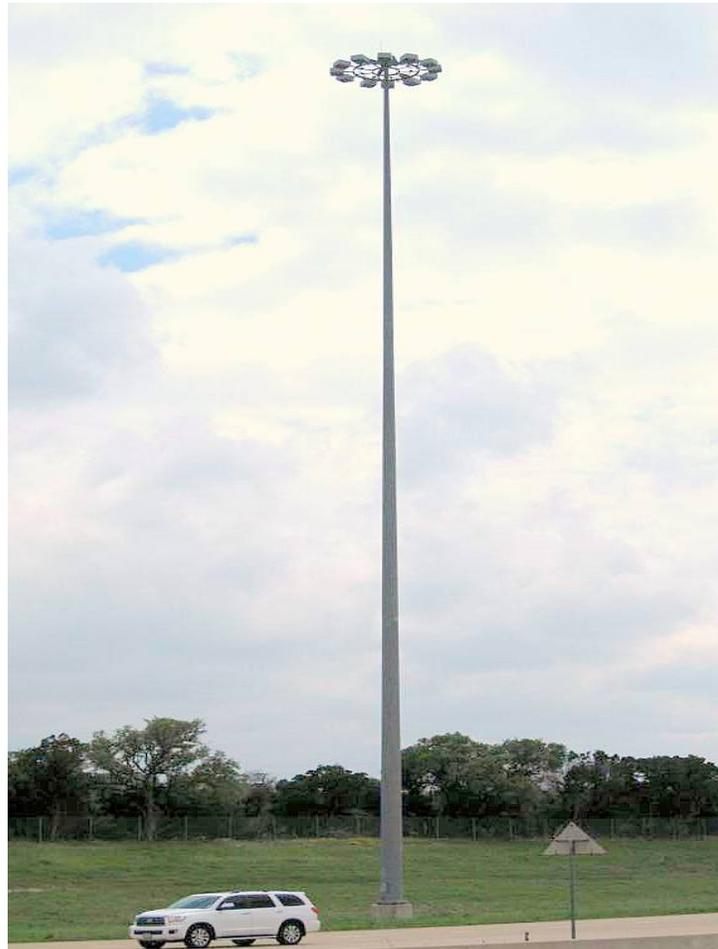
Figure 13 – High Mast Light Tower

Similar to overhead/cantilever signs, HMLTs were inspected by TxDOT at the completion of their construction. No deficiencies were noted during the post construction inspection. These structures, like the one pictured in Figure 13, provide illumination for improved nighttime visibility at various locations along the CTTS, such as interchanges and toll facilities. The condition of high mast light towers is determined by the two components listed in Table 17 below. Beginning in FY 2011, the HMLTs will be inspected biennially. In FY 2011, the HMLTs for SH 45 were inspected. Next year, the HMLTs for Loop 1 and SH 130 will be inspected. The results of this year's inspection indicate that SH 45's 61 HMLTs are in very good condition. A total of 16 minor deficiencies were found to be in need of repair. These items have been reported to Austin District Maintenance. A summary of the results and the items in need of repair can be found in Appendix D.
