September 2019

## **Loss of Backfill in Mechanically Stabilized Earth Retaining Walls**

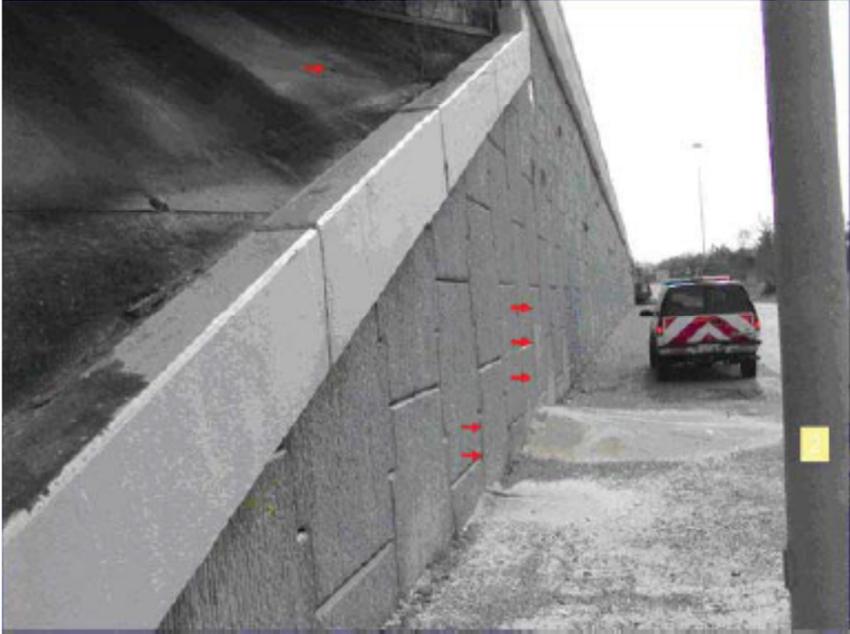
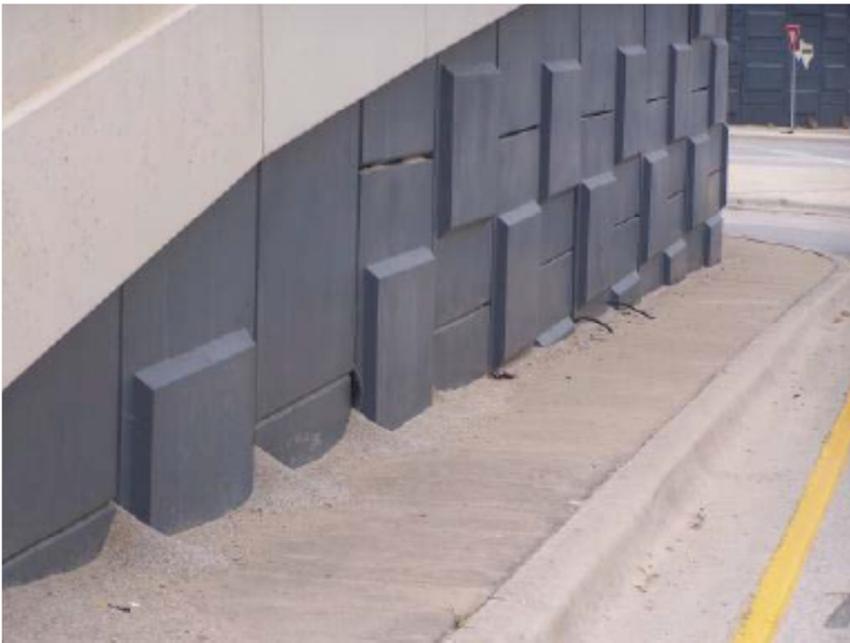
The problem is caused by surface water entering the top of the wall and then transporting select material out through joints or other openings in the wall. Incidence of backfill loss is most commonly associated with very fine, uniform "sugar sands" that were allowed in past specifications, although some more recent cases have involved coarser backfills.

Mounds of select backfill appearing at the base of a wall after heavy rains are likely to signal backfill loss. As the problem becomes more advanced, voids form behind the wall face, sometimes causing precast panels to shift outward due to loss of anchorage, and causing roadways above the wall to settle due to loss of support. In extreme cases, portions of roadways and concrete riprap have ultimately collapsed into voids up to several cubic yards in size.

Examples of MSE retaining walls exhibiting loss of select backfill.

The solution to the problem is to identify all areas where water is entering a wall and then seal those locations to prevent further infiltration. The site of infiltration can often be above the area where backfill is being found at the base of the wall. Sealing these areas may require regrading of the ground behind the wall, repair of flumes, or extensive sealing of flume and coping joints. As a rule, use either silicone or hot rubber sealers to seal joints.

Fill any identified voids to restore structural integrity and stop further loss of material. TxDOT recommends Flowable Backfill (Item 401) for filling these voids, although some districts have used expandable foam (Uretek) for the same purpose. Locate voids by probing from the surface and from the face of the wall. For more detailed mapping, use Ground Penetrating Radar or coring and visual inspection.

After filling any known voids and sealing the top of wall, evaluate the panel joint openings at the face of wall. If panels were placed with very wide joints or have shifted and left obvious wide, unprotected joints, consider sealing those joints. Seal any joint where the filter fabric is missing and backfill is exposed. While it is preferable to leave most joints open as they provide relief for water pressure that may build up inside of a wall, it is acceptable to seal a percentage of the wall joints. Joints are typically sealed by placing a backer rod and then using a non-sag silicone sealer (DMS-6310, Class 4).
