TIPS

Published: June 2002
Revised: January 2008

Premature Failure of Asphaltic Pavement Bordering Vehicle Wire Loop

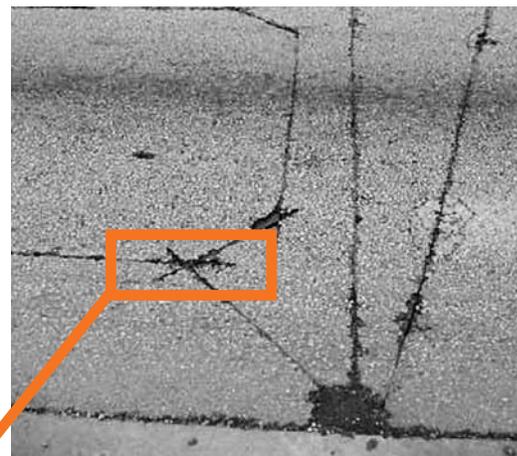
The Materials and Pavements Section determined the cause of the failure to be the sealant used to encapsulate the vehicle wire loop. The material was expanding during its cure. In service, this expansion and traffic produced added stresses that began to disintegrate the adjacent asphalt pavement.

Loop detector sealant causing failure of surrounding pavement

This failure prompted us to review the materials used for sealant, the materials' specs and testing frequencies. We found that 1) there are many materials that could be used for loop detector sealant, 2) the material specs failed to address the problems exhibited and 3) materials used were rarely tested. After field research; laboratory testing; and district, division and producer input, we developed DMS-6340 "Vehicle Wire Loop Sealant" to address the material characteristics that led to past failures.

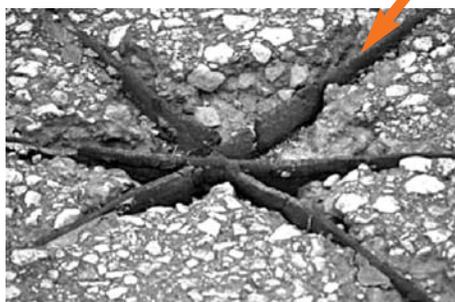
Close-up of corner of a vehicle wire loop installation. Erosion and chipping herald the start of major spalls in flexible pavement

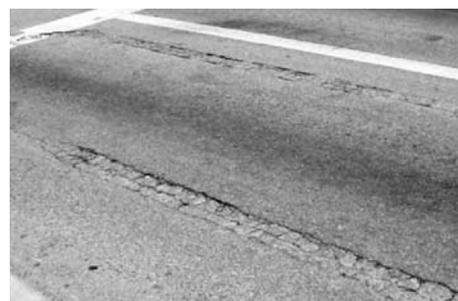
Overlay failure from underlying loop detector sealant problem
