# Cable Barriers: Texas Research

Scott Cooner, P.E.  
Program Manager

Texas Transportation Institute – Arlington Office

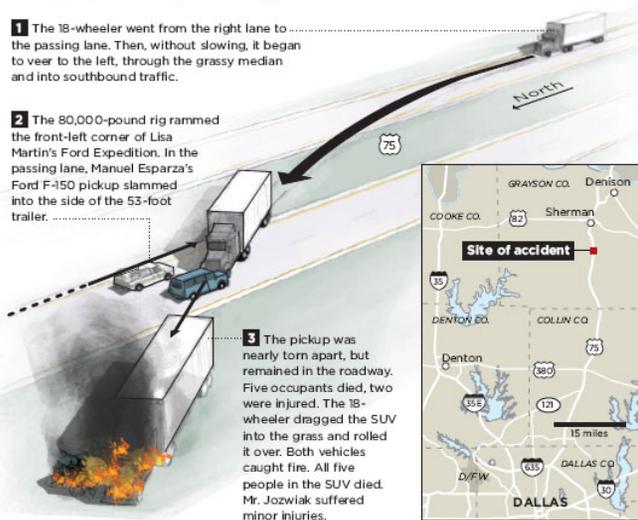
## HOW THE ACCIDENT HAPPENED

About 4:29 p.m. on Sept. 20, 2004, Miroslaw Jozwiak was driving his 18-wheeler north on U.S. Highway 75 at 65 mph. What happened next:

**1** The 18-wheeler went from the right lane to the passing lane. Then, without slowing, it began to veer to the left, through the grassy median and into southbound traffic.

**2** The 80,000-pound rig rammed the front-left corner of Lisa Martin's Ford Expedition. In the passing lane, Manuel Esparza's Ford F-150 pickup slammed into the side of the 53-foot trailer.

**3** The pickup was nearly torn apart, but remained in the roadway. Five occupants died, two were injured. The 18-wheeler dragged the SUV into the grass and rolled it over. Both vehicles rolled over. Both vehicles caught fire. All five people in the SUV died. Mr. Jozwiak suffered minor injuries.

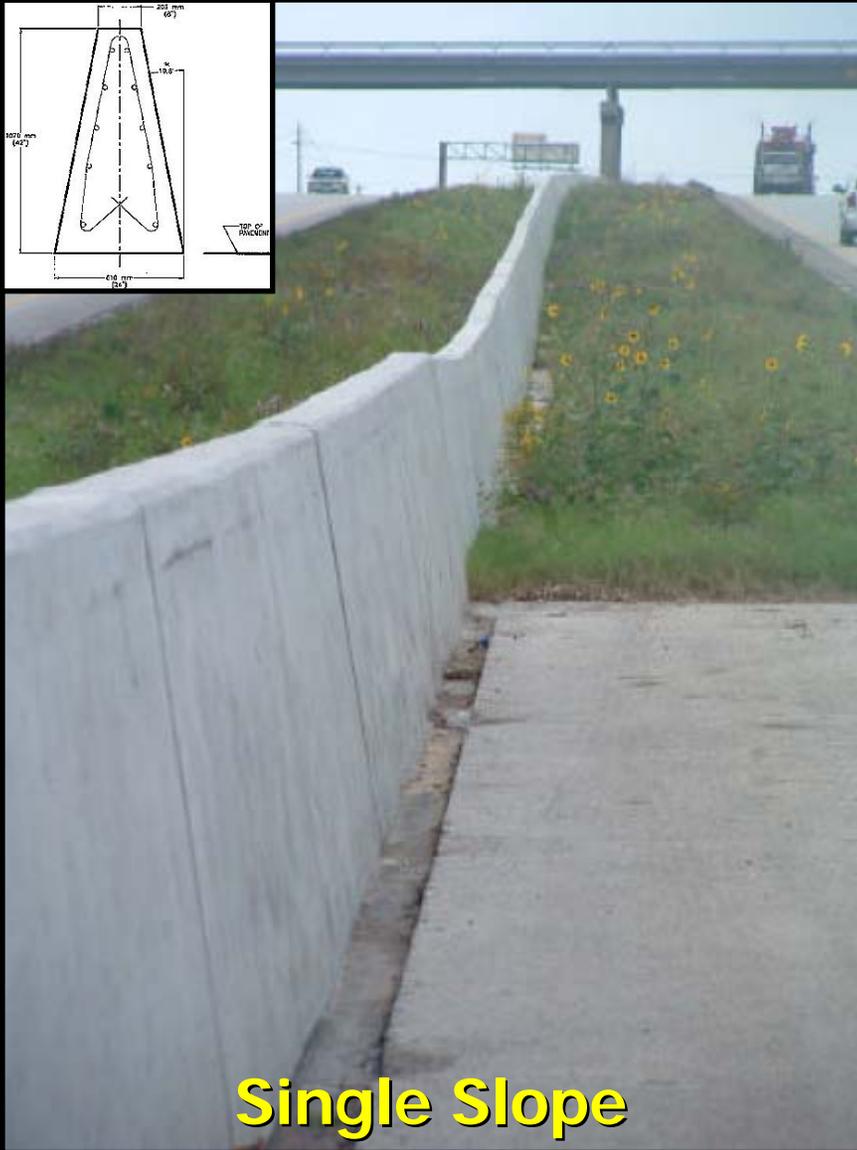
**Single Slope**

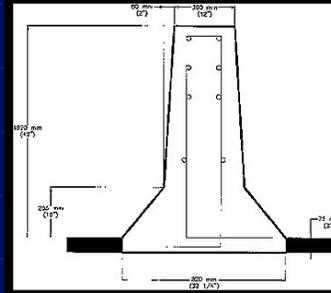
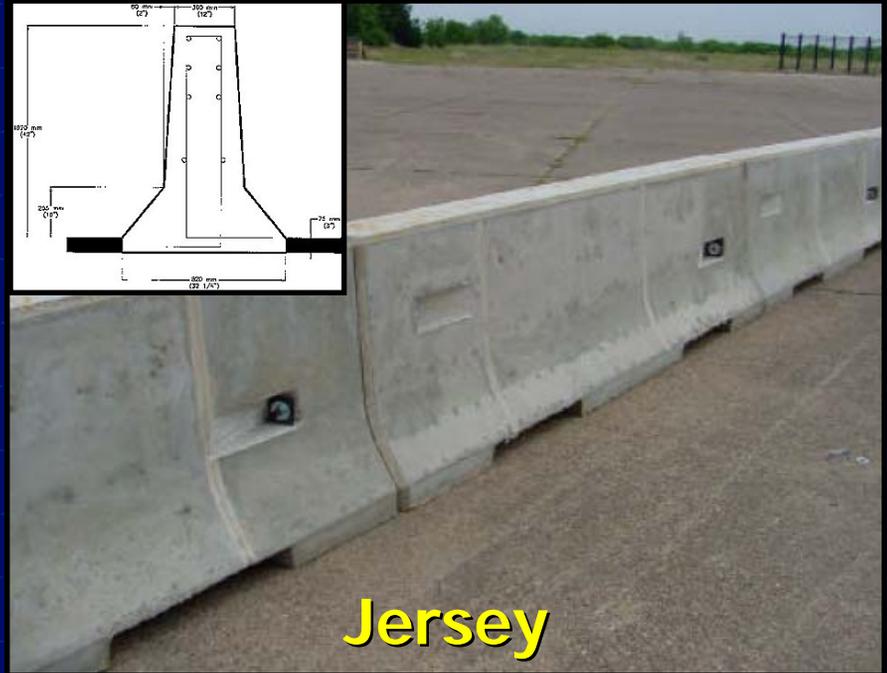
**Jersey**

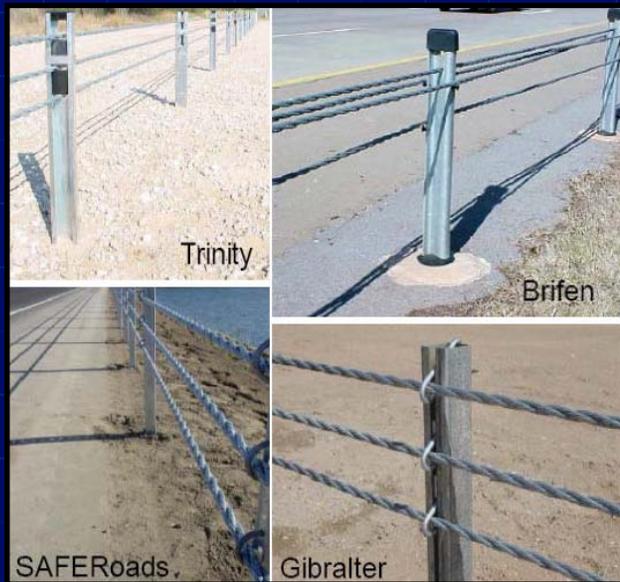
Left: A standard three-strand cable median barrier is shown.  
Below: A high-tension four-strand cable median barrier is shown.

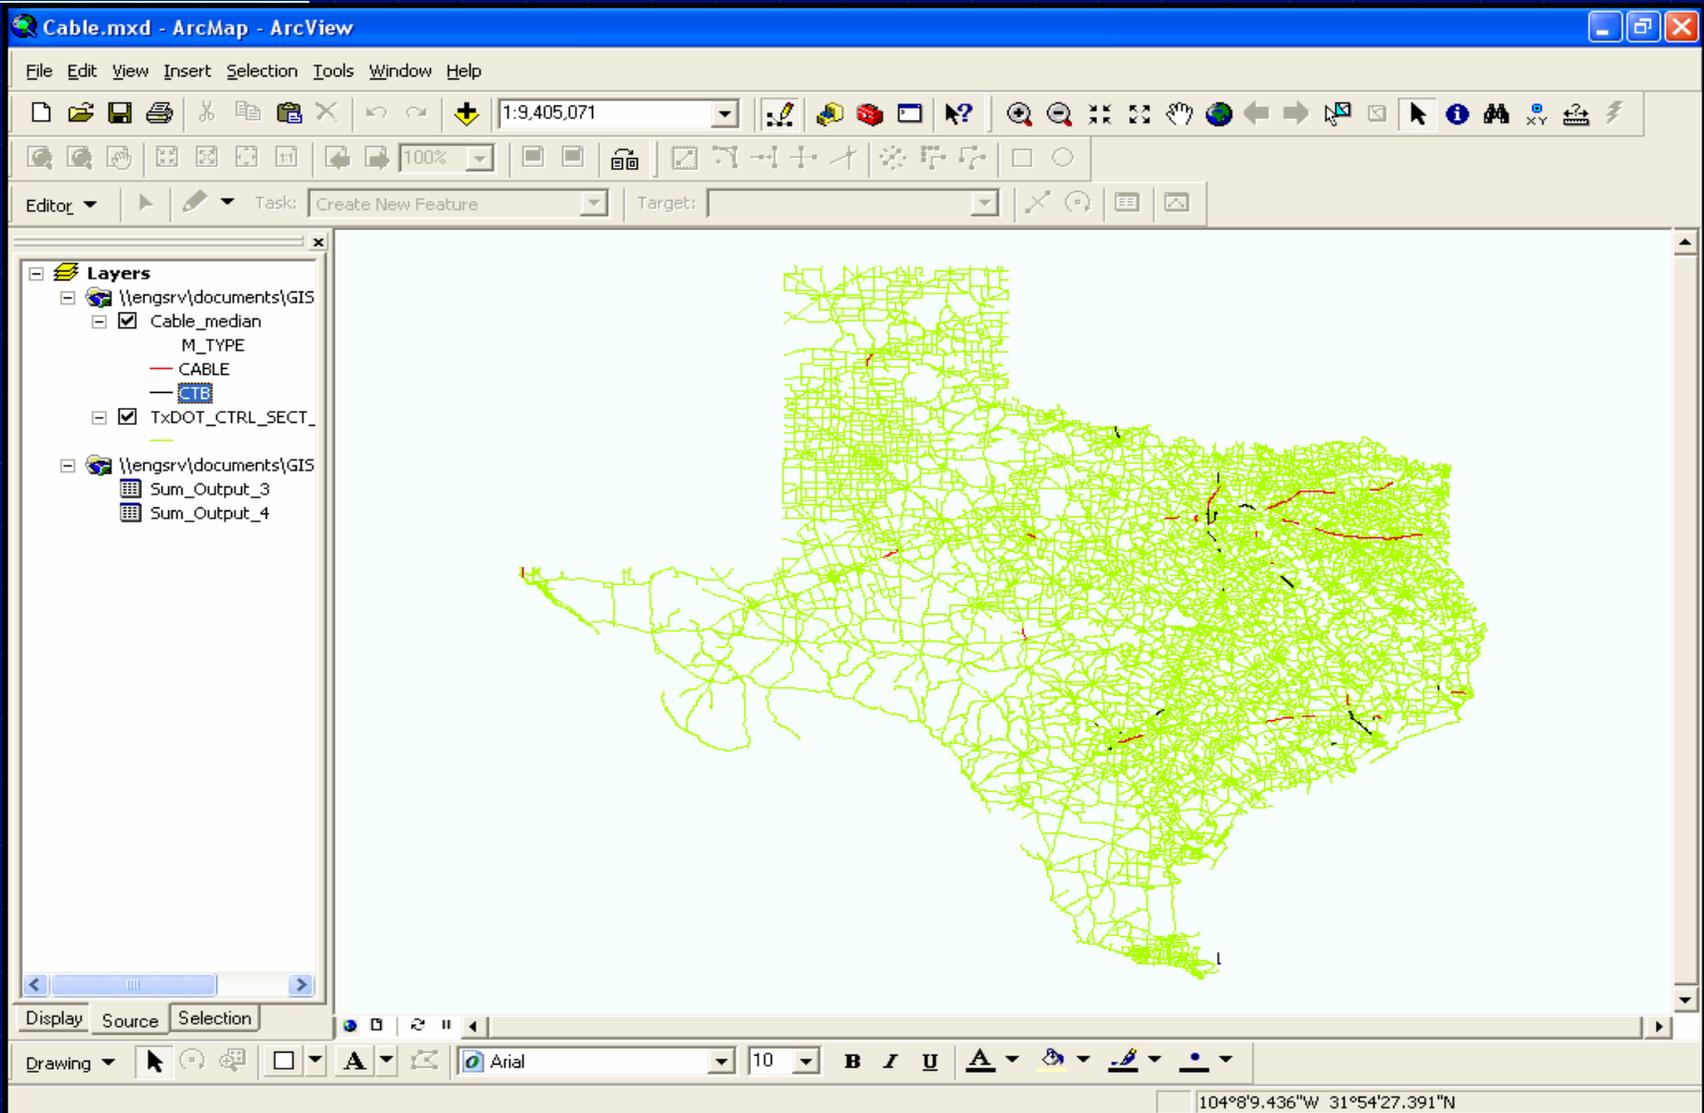
# 5609 Research: GIS Analysis

**Note: red line = cable barrier and black line = concrete barrier**

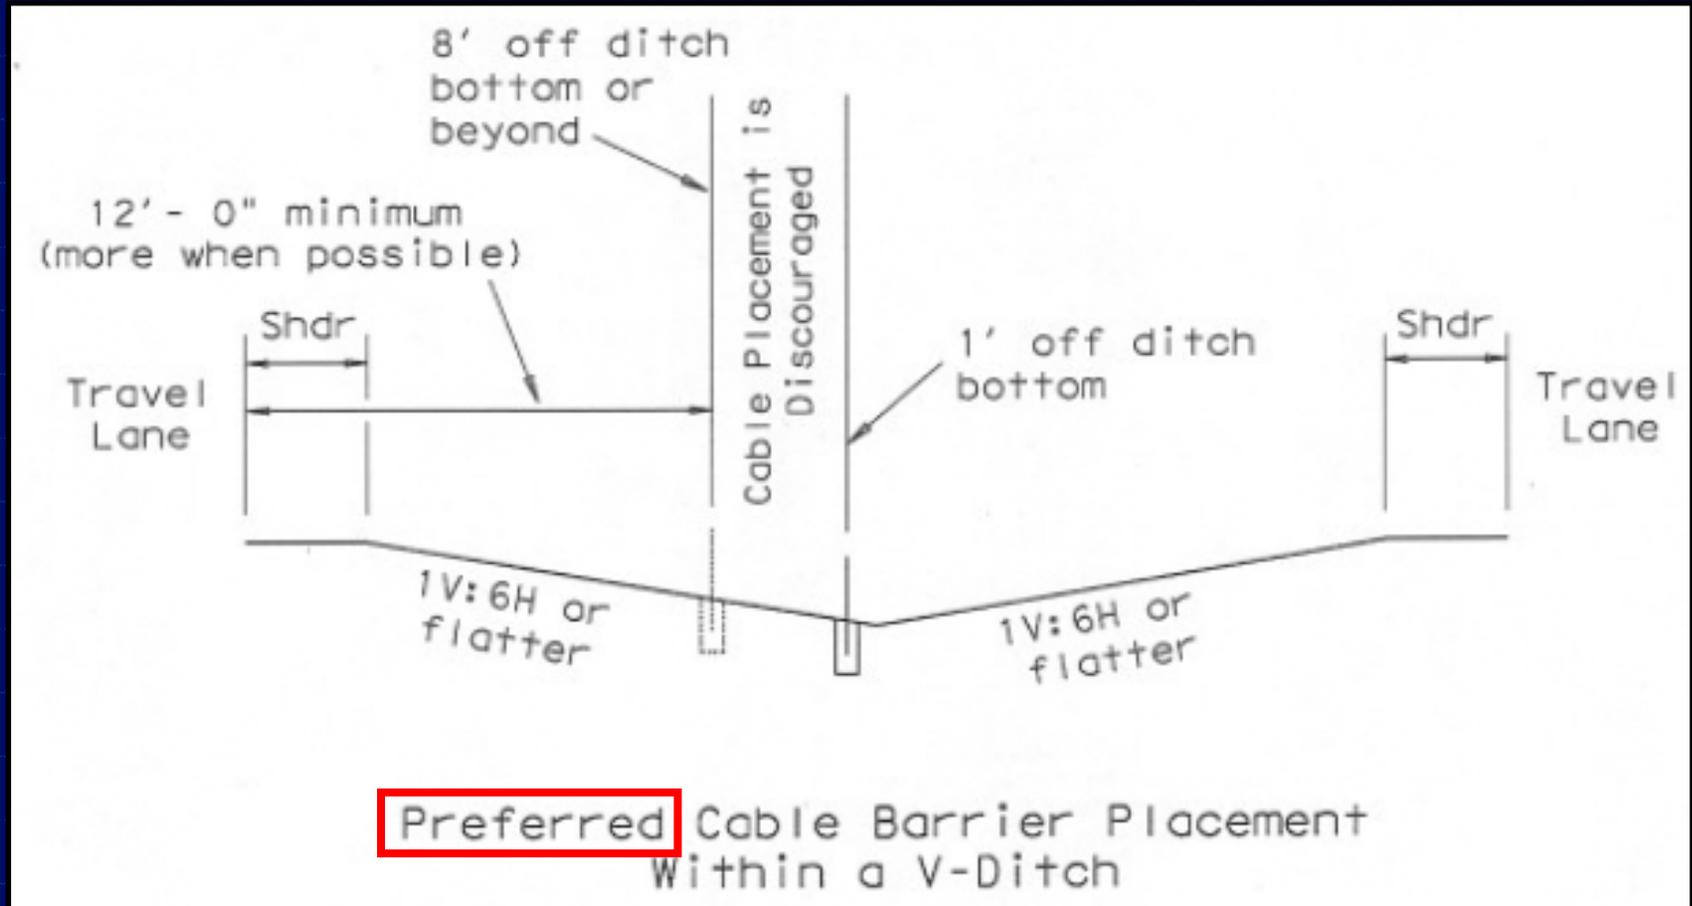
# Design: Placement

TxDOT Design Division memorandum dated June 21, 2006

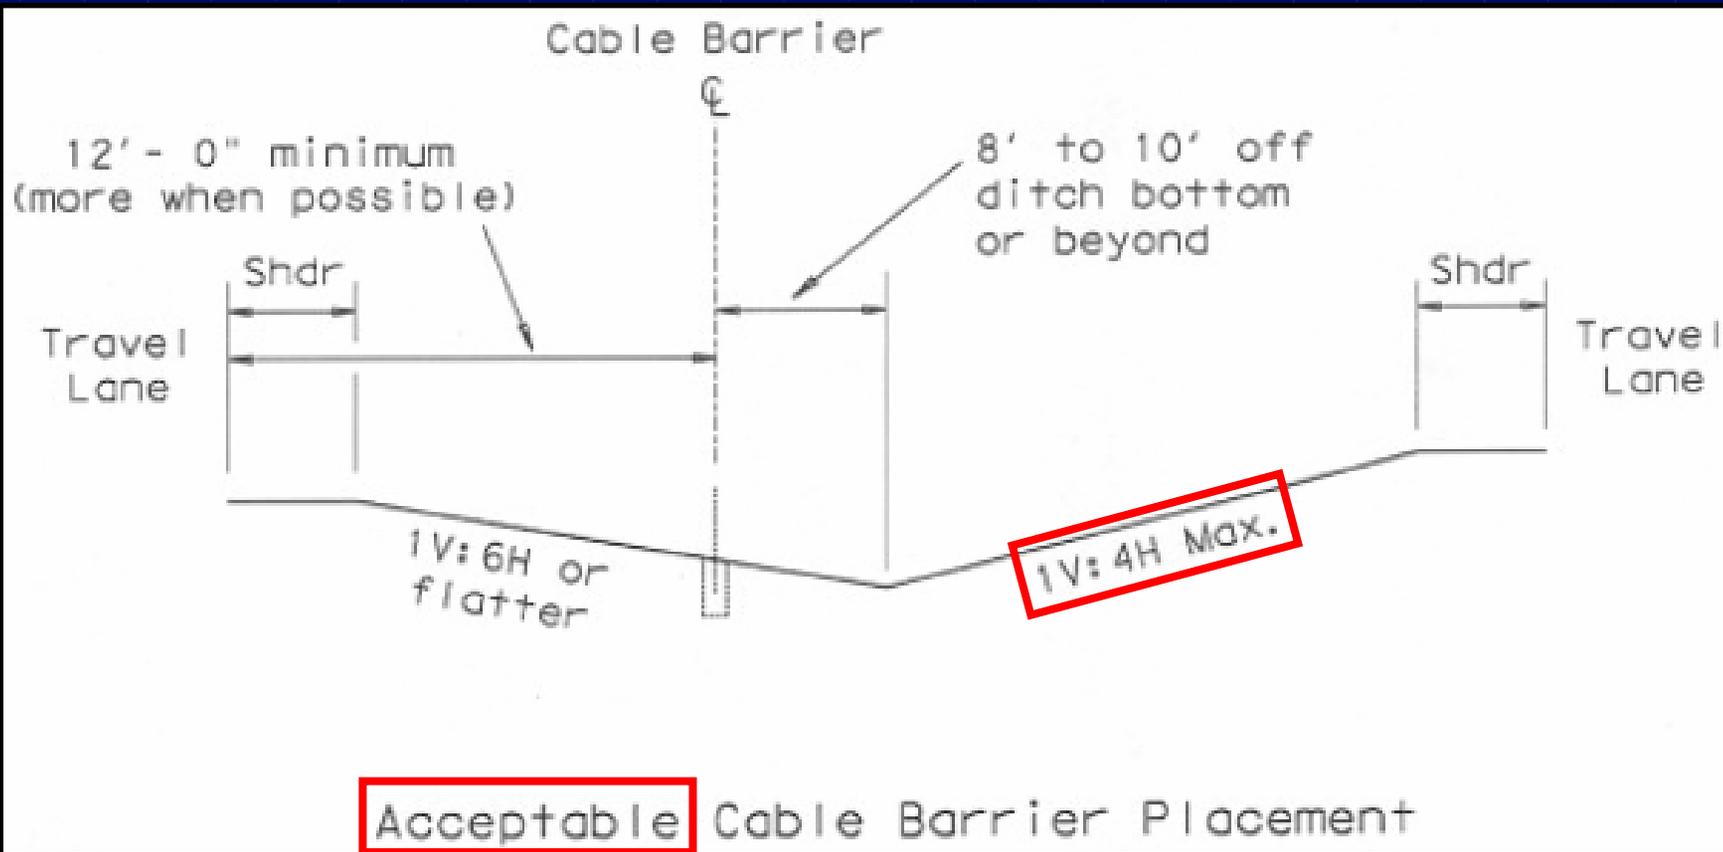
# Design: Placement

TxDOT Design Division memorandum dated June 21, 2006

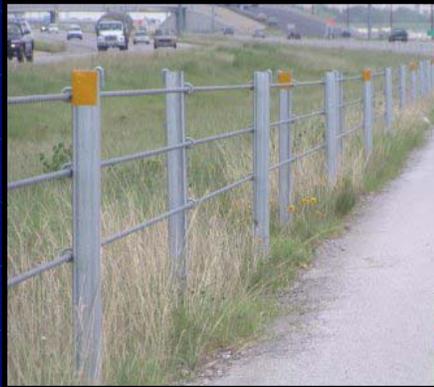
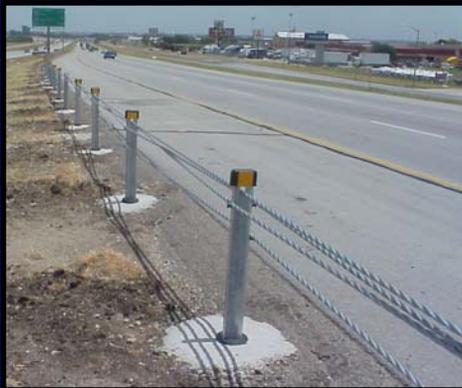
**Socketed**

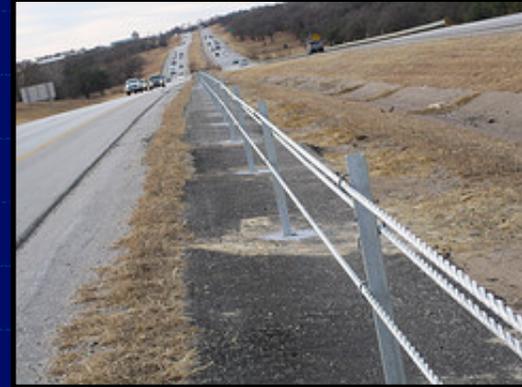
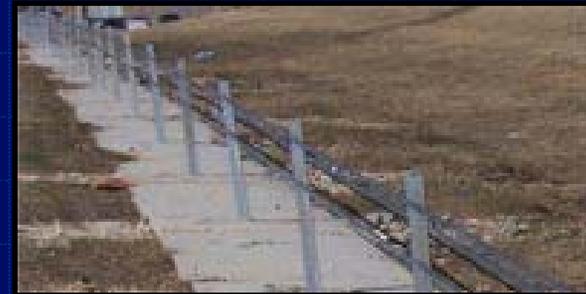
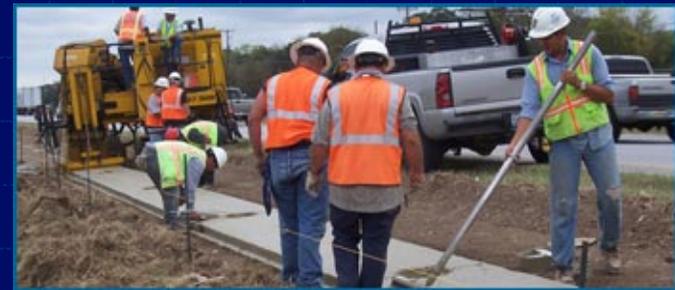
**Mow Strip**

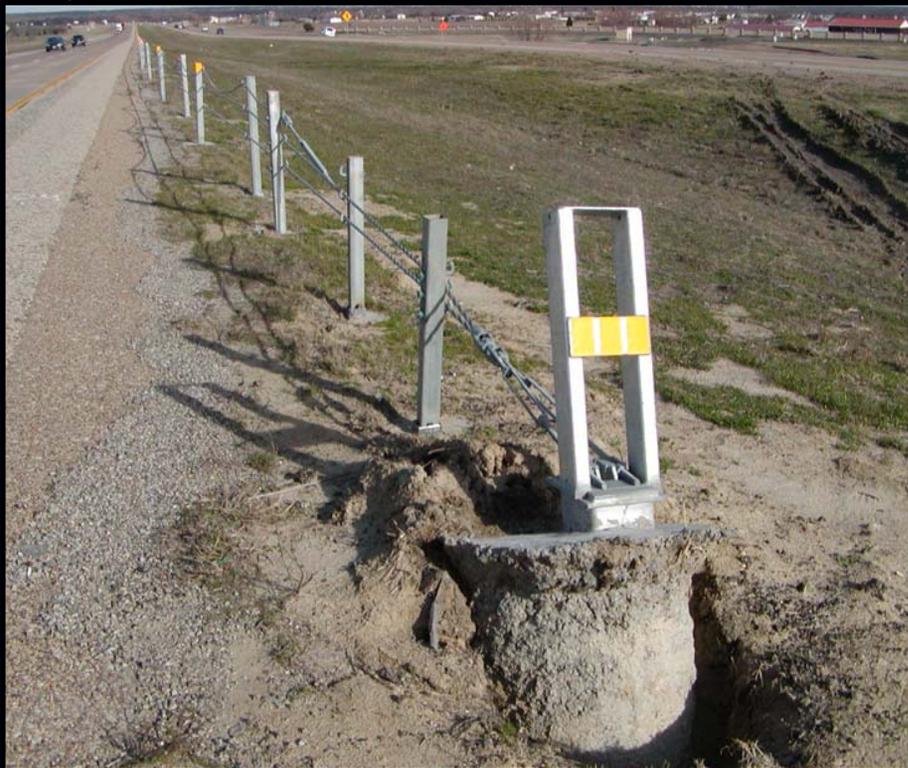
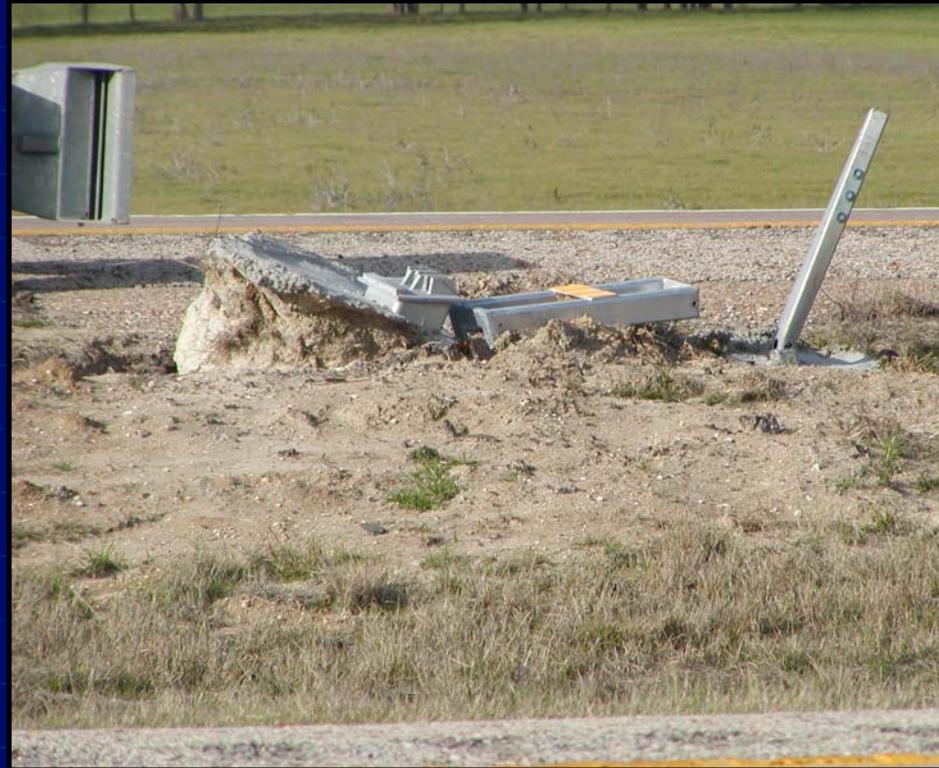
**I-20 Kaufman County**

# Key Issue: Anchor Design

- ❖ Soil conditions
- ❖ Weather concerns

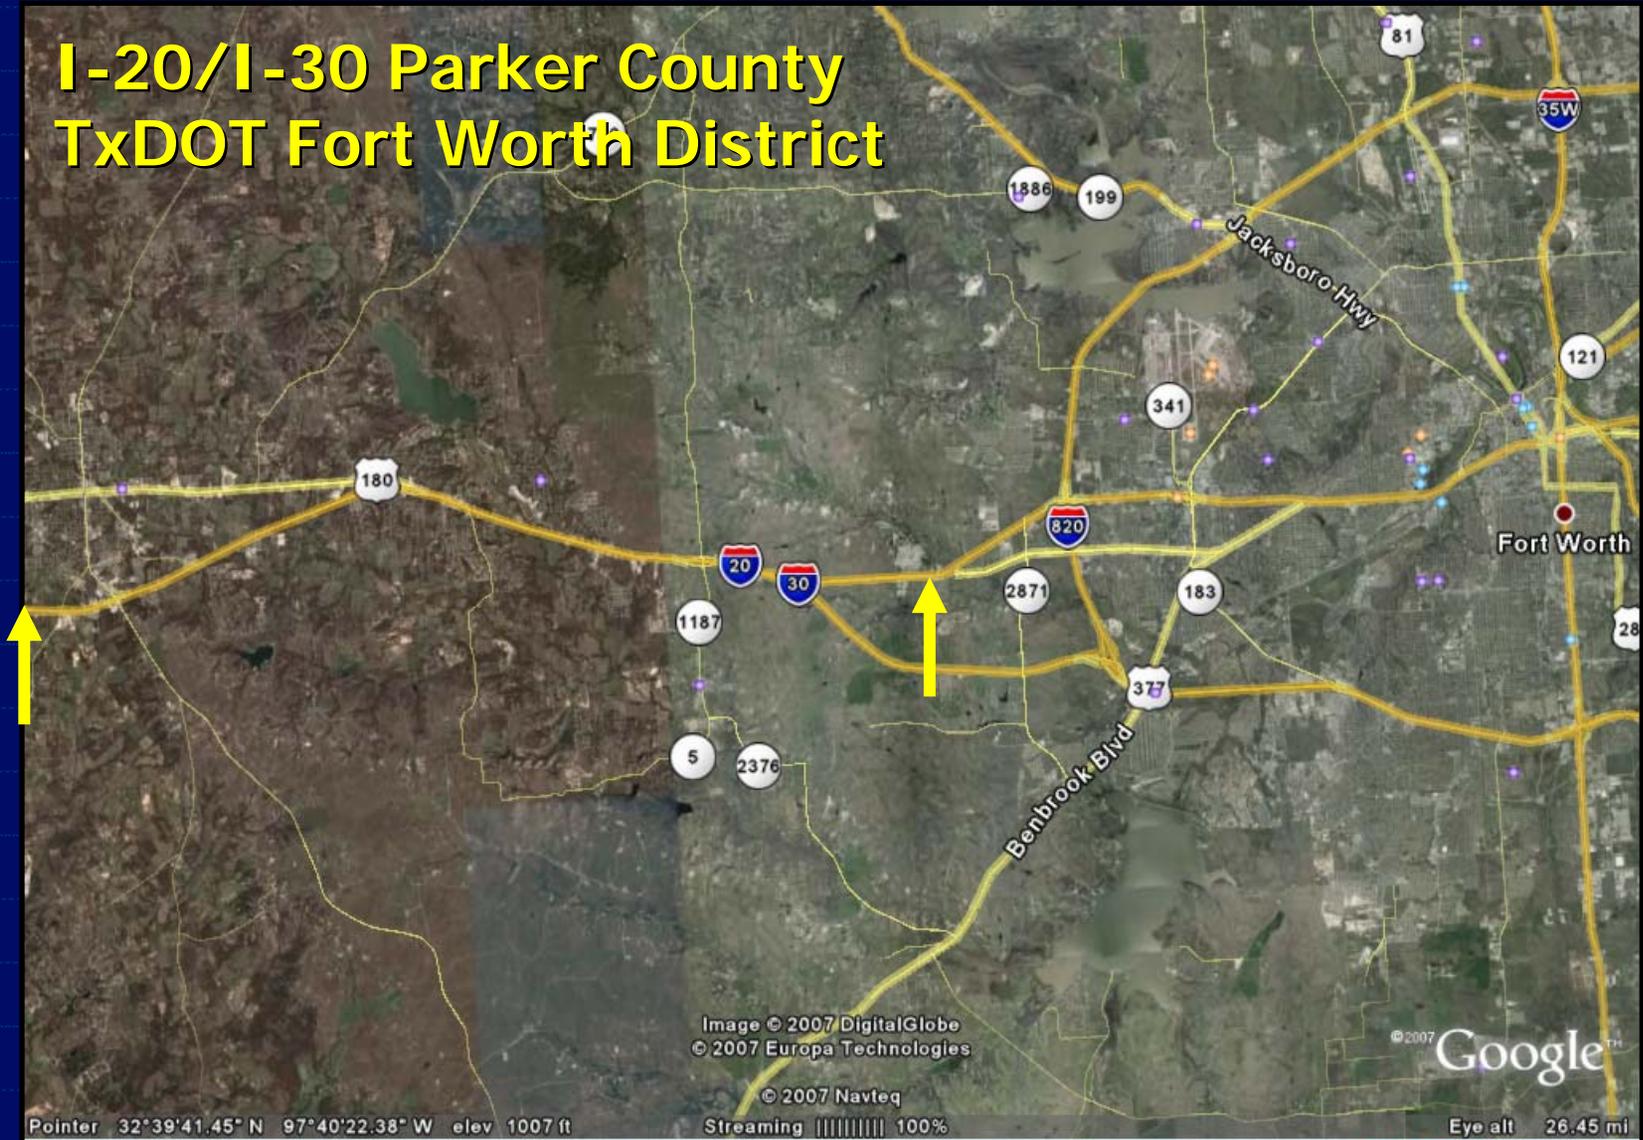
## I-20/I-30 Parker County TxDOT Fort Worth District

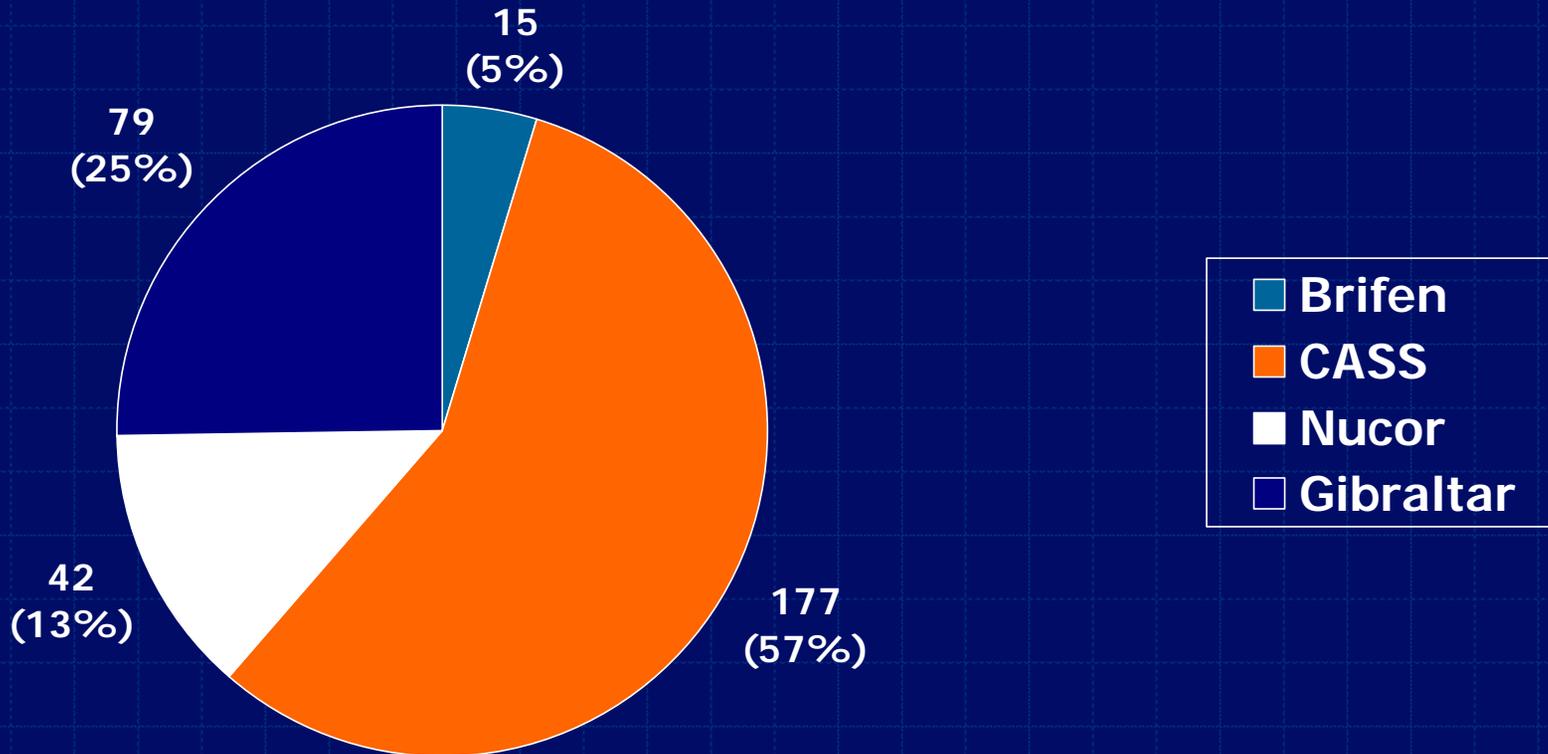
## Total Miles of Different Types of Cable Barrier System Installed in Texas

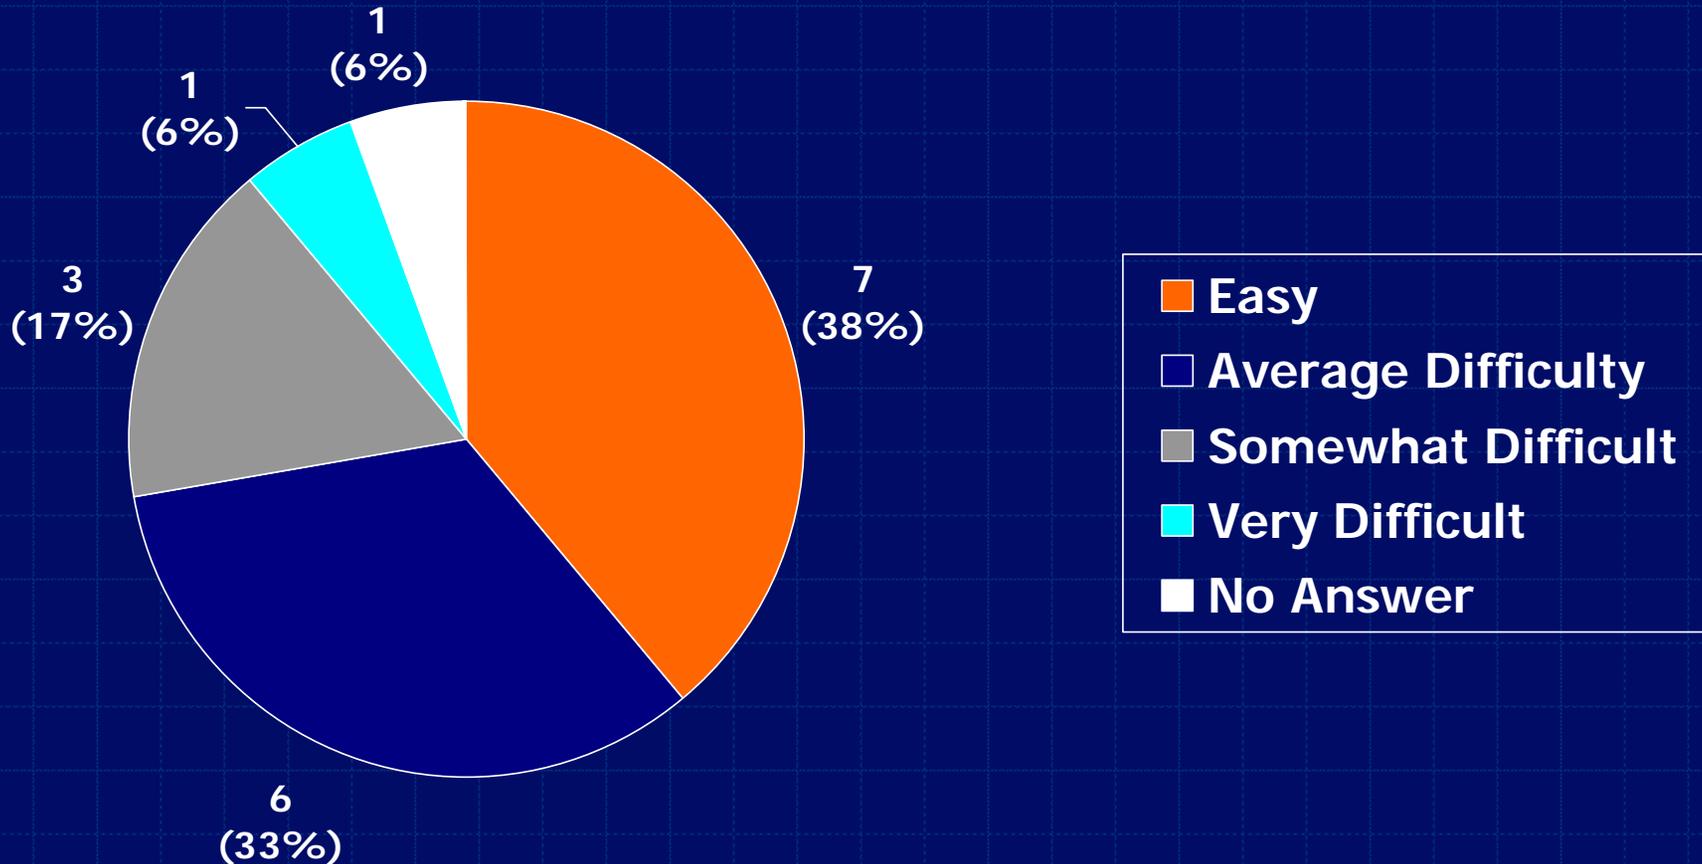
## Level of Difficulty in Repairing the Cable Barrier System

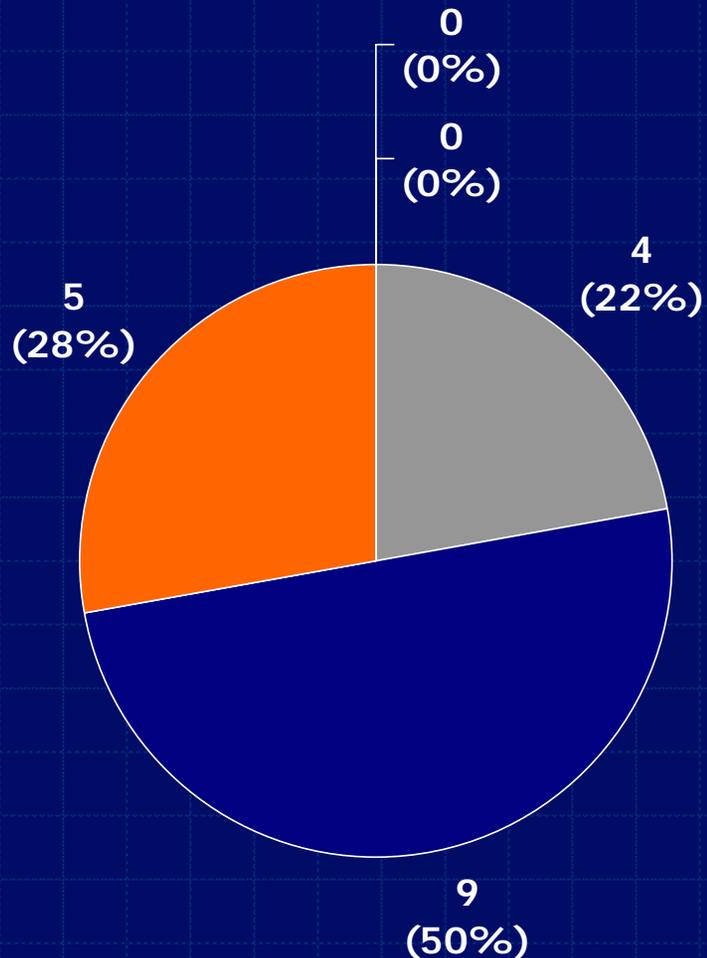
## Availability of Repair Parts

- Always Available
- Average Availability
- Somewhat Difficult
- Very Difficult
- No Answer

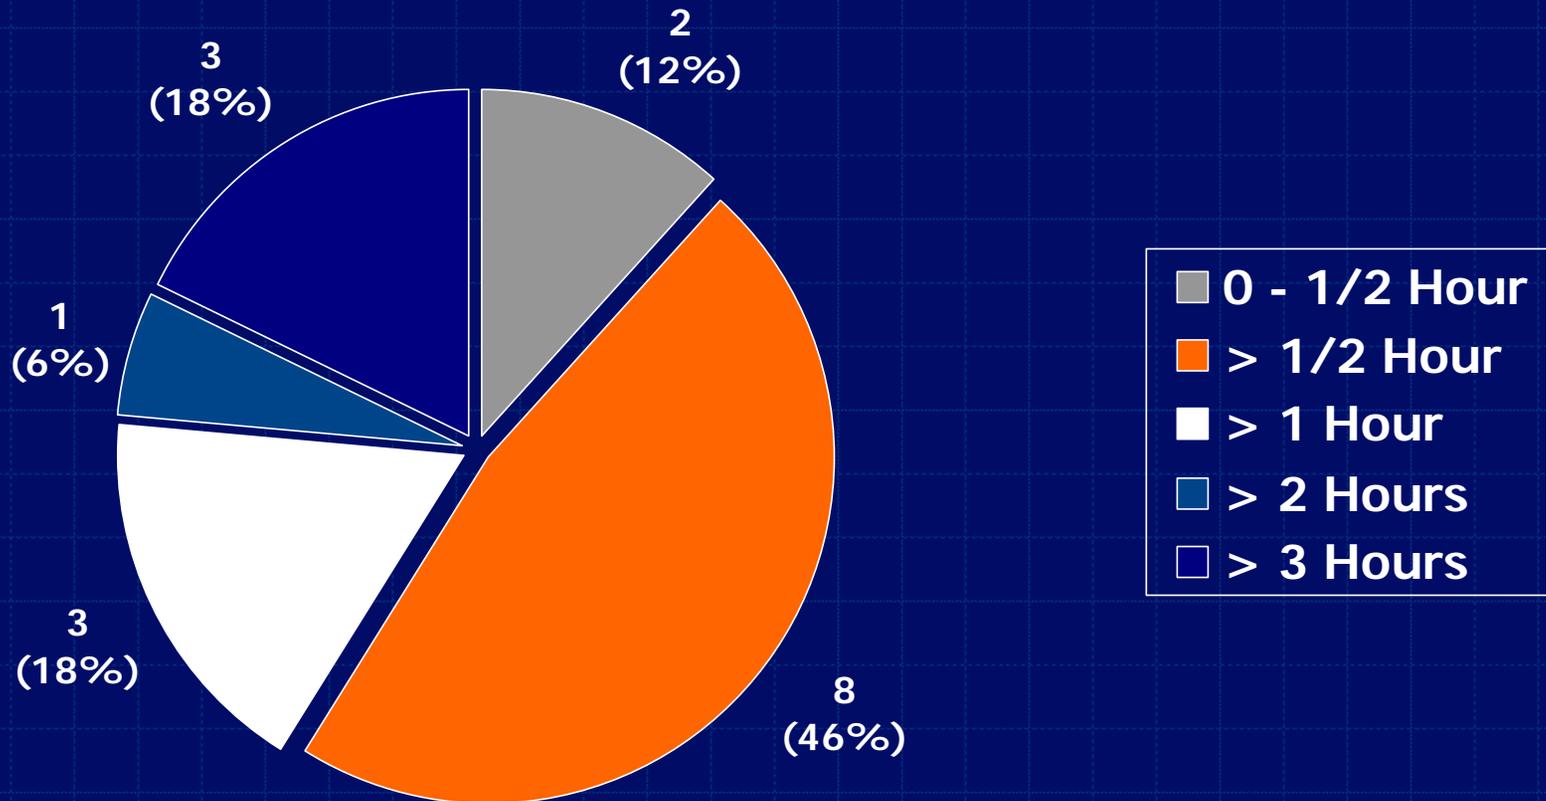
## Average Time Spent on Repairs

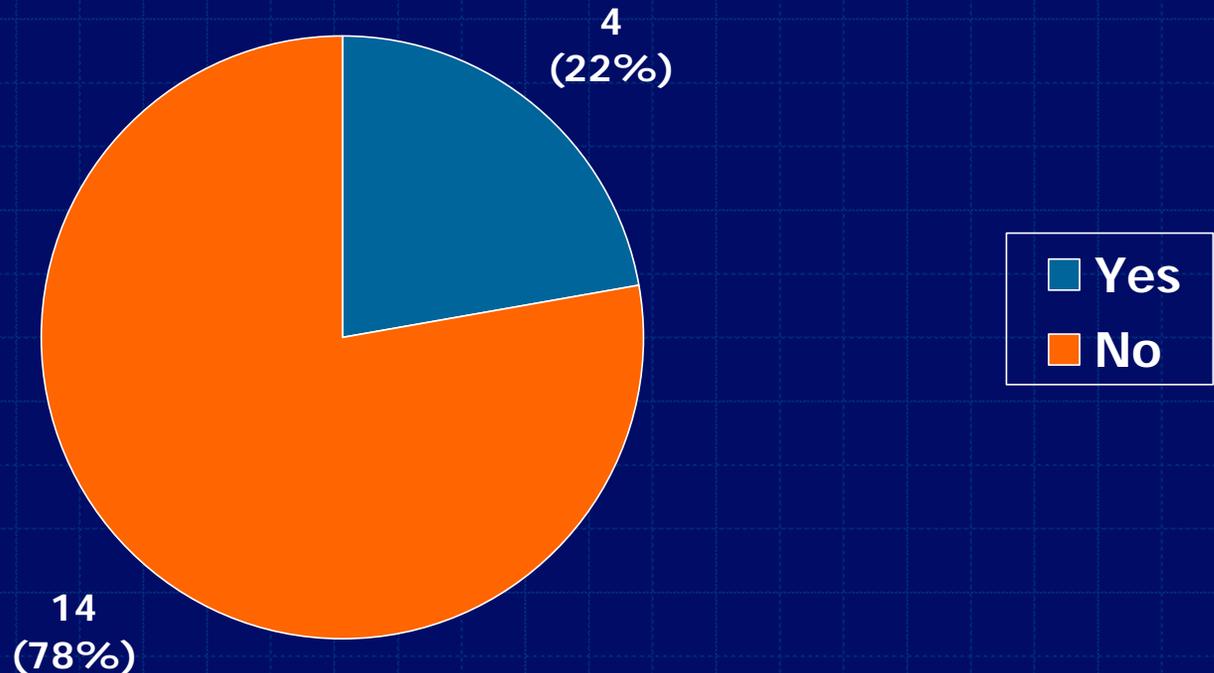
**Number of Maintenance Sections with Penetration of Passenger Vehicles through the Cable Median Barrier System**

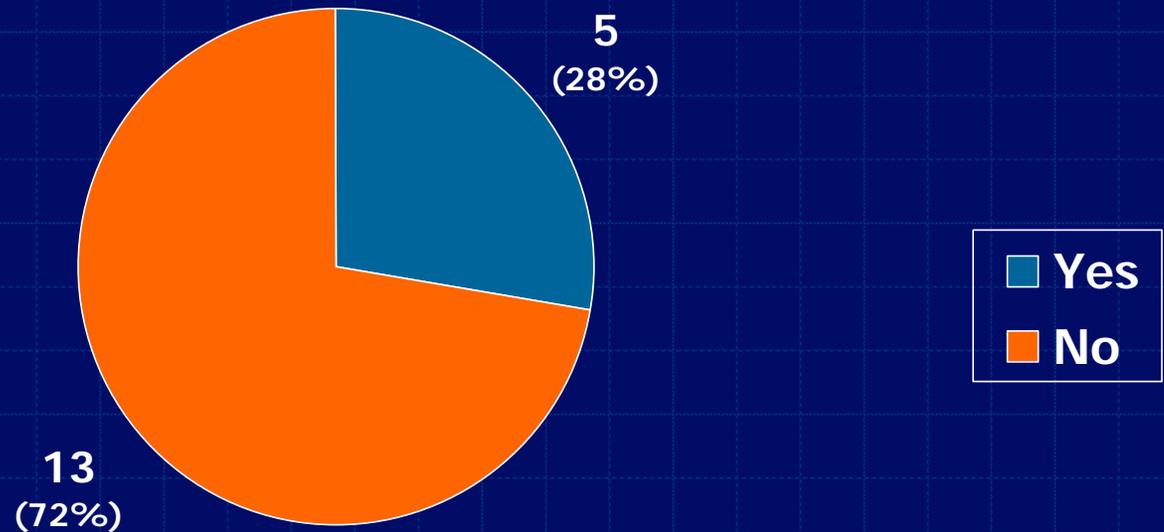
## Number of Maintenance Sections with Penetration of Trucks through the Cable Median Barrier System

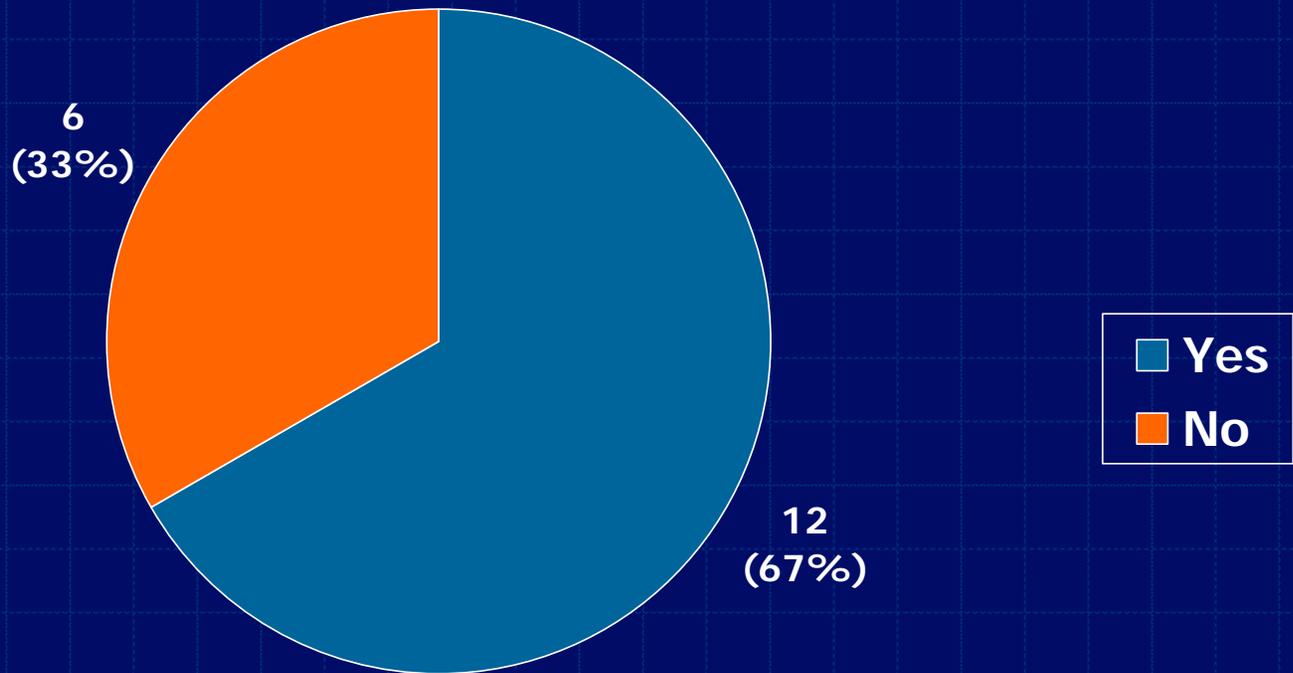
## Number of Maintenance Sections with Mow Strips along the Cable Barrier System Installation
