DATE: 8/31/2021 2:40:39 PM FILE: I:\BWD\SGTEAM\Jacob Perry\Bridg Maintenance Contract FY21\US 183 HUBBARD CREEK.dgn

Sta. 515+65 - 519+60
 3 Continuous Steel I - Beams
 & 5 Simple Span Reinforced
 Concrete Pan Girder Bridge
 On Concrete Column Bents

US 183 @ HUBBARD CREEK
232150040402015
STEPHENS CO.

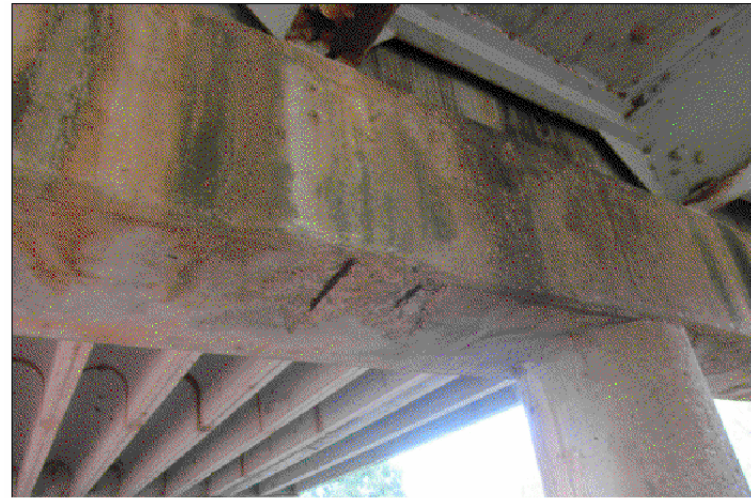
PHOTO #1

Note: Cap at bent 6 from NW has minor horizontal cracks along top edge and minor to moderate delaminations and spalls (up to 27"x18") with exposed rebar at underside.

SPALL AT BENT 6
 CAP
 Looking NW
 IMG. 317

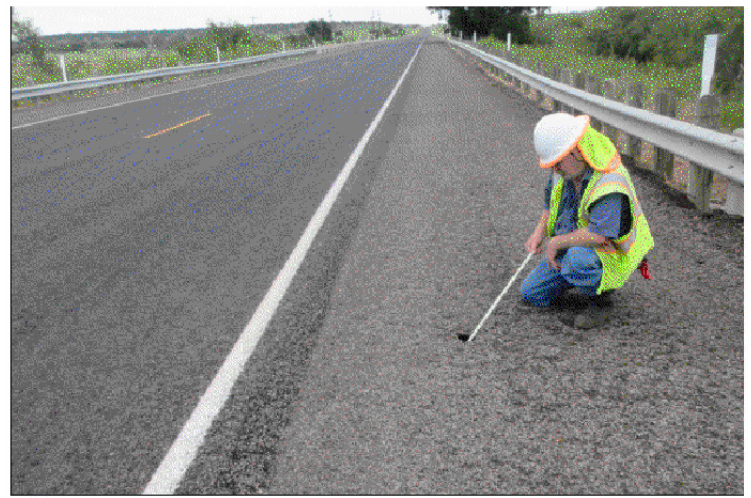
PHOTO #2

Note: Erosion hole approximately 3" in diameter and 4" from white stripe of Southbound lane and depth greater than 4" on SE end of bridge.

EROSION HOLE AT
 SE END OF BRIDGE
 Looking E
 IMG. 310

ITEM	CODE	DESCRIPTION	QUANT	UNIT
401	6001	FLOWABLE BACKFILL	1	CY
429	6007	CONC STR REPAIR (VERTICAL AND OVERHEAD)	4	SF
446	6028	SPOT CLEAN & PAINT EXIST STR (SPL PRT SYS)	1	LS
429	6023	CONC STR REPAIR (PAN GIRDER HOLE REPR)	70	EA
427	6006	EPOXY WATERPROOF FINISH	320	SF
