# Historic Bridge Adoption Information Packet

Comanche County

County Road (CR) 382

Resley Creek

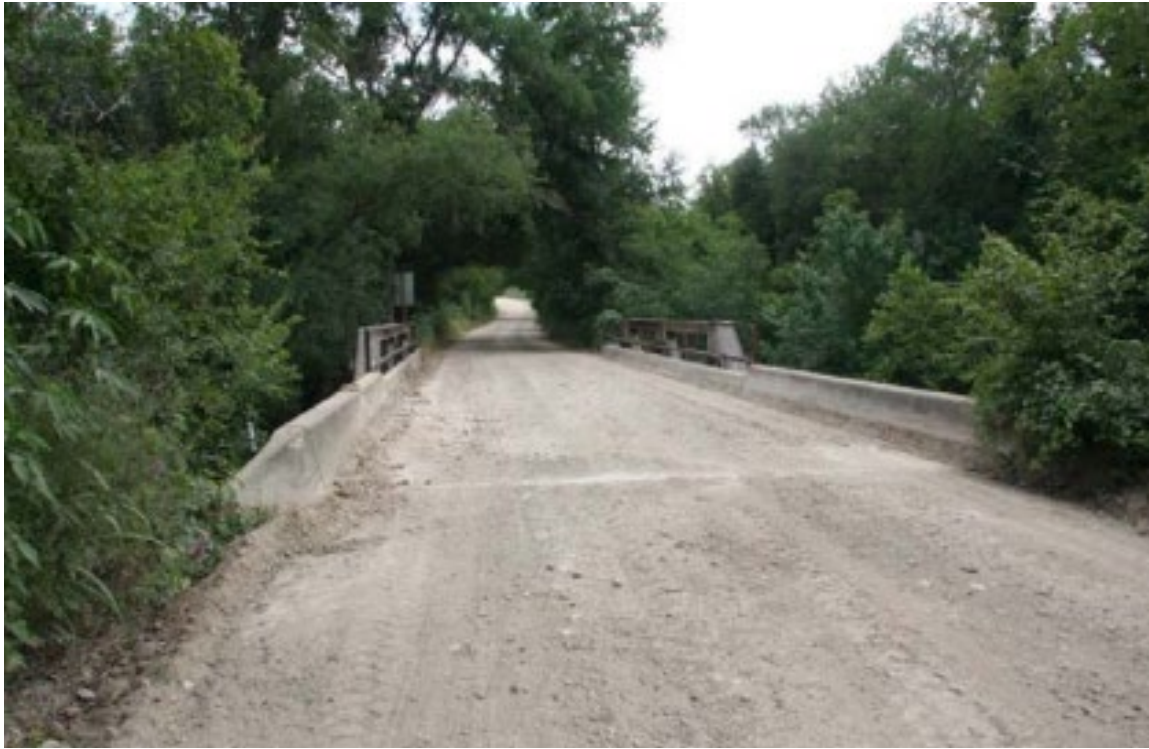
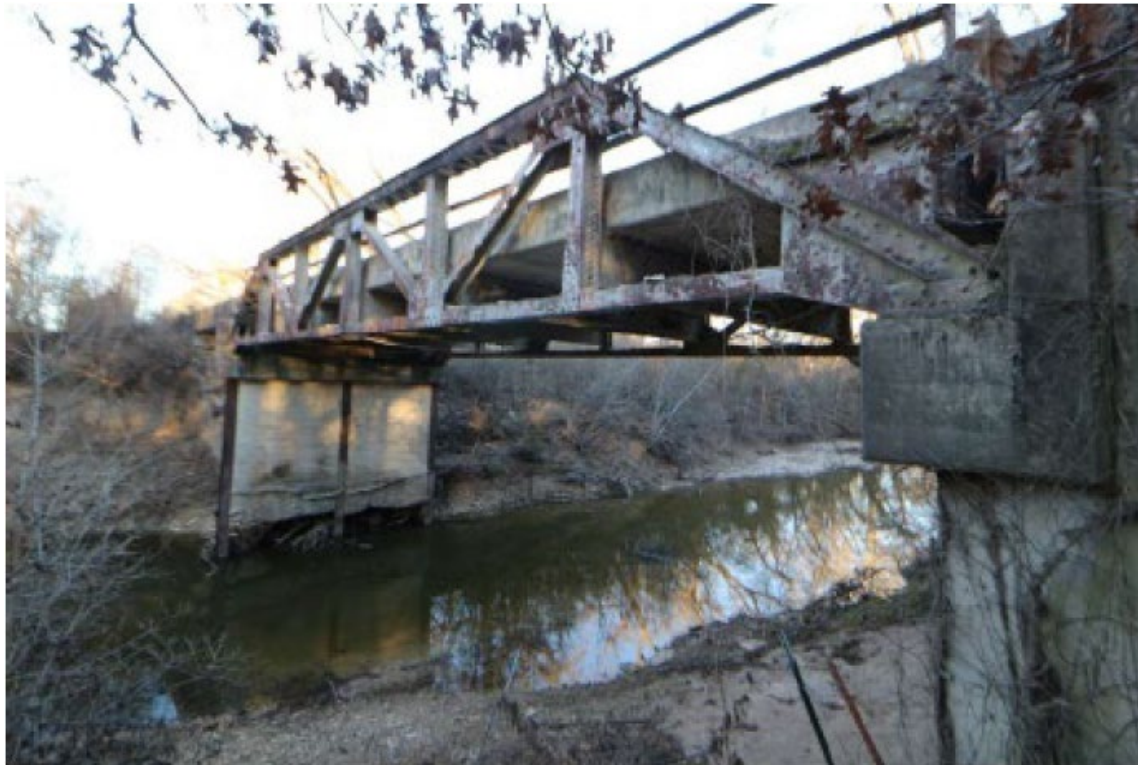
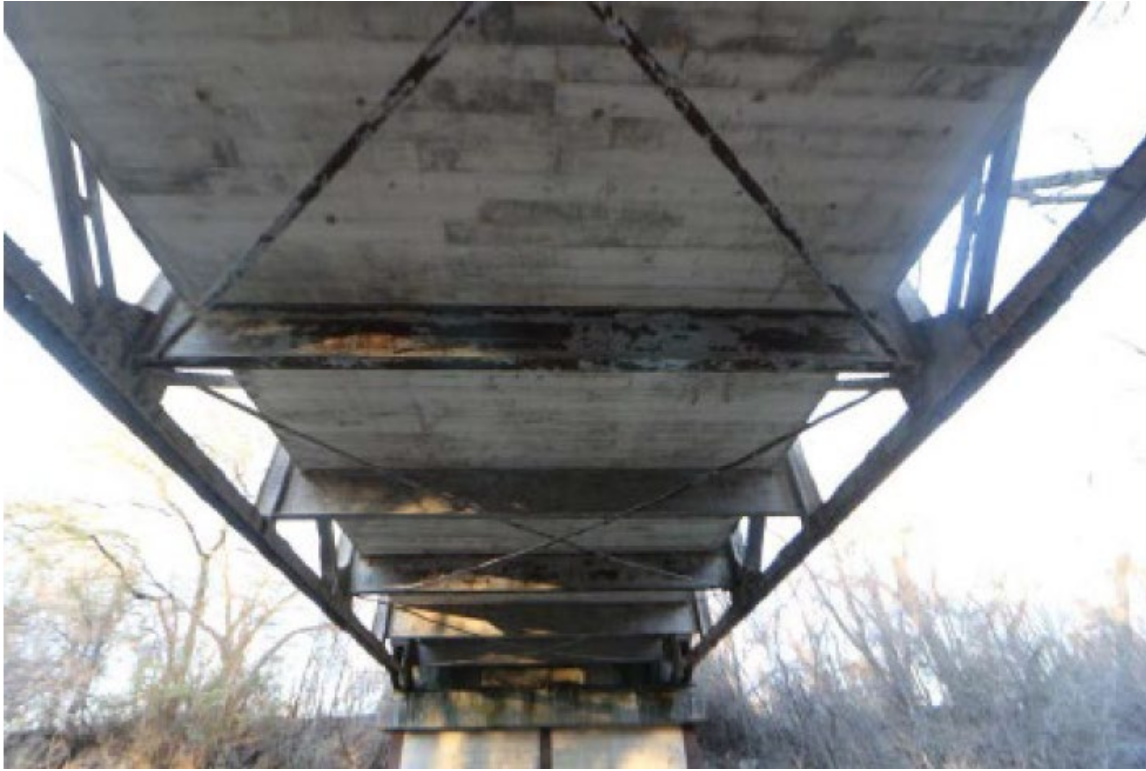
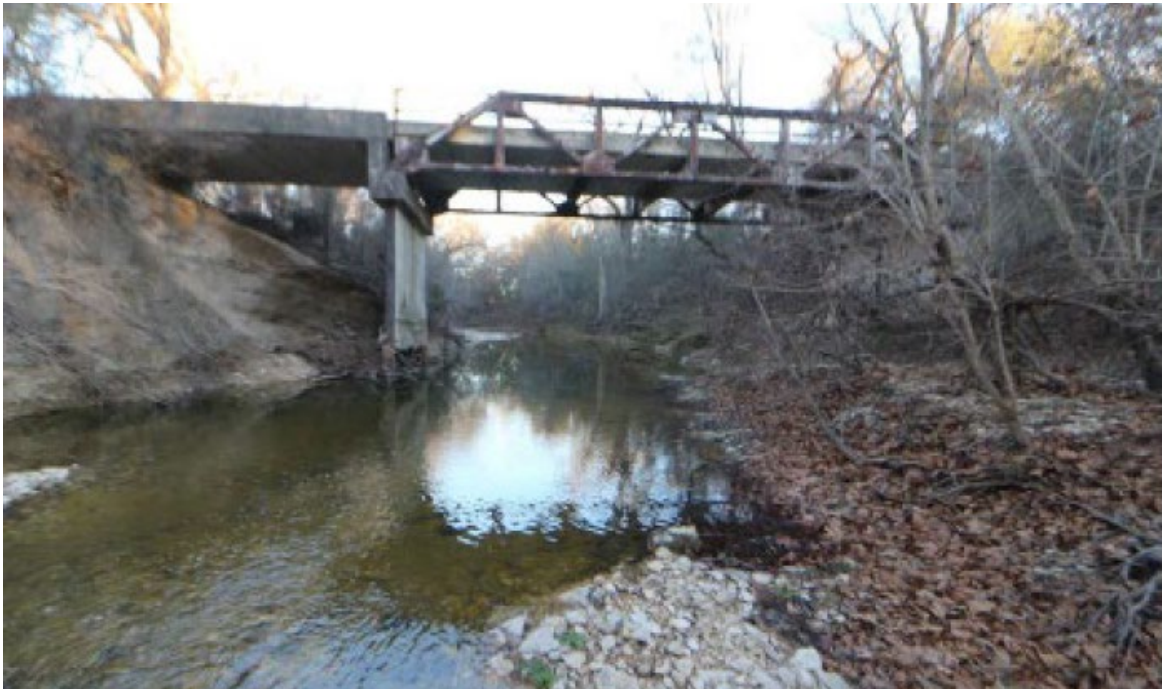
## Bridge Photographs

The bridge is currently in Fair condition. The truss beams have widespread minor paint failure and rust. Multiple truss members are deformed. The top concrete deck has minor wear, cracks, and spalls. The north bank under the bridge and upstream from the bridge has severe erosion which is undermining the interior bent and web wall, indicating the need for a longer span. Concrete wingwalls have minor cracks and spalls. The bridge's current load rating is not sufficient to carry ambulances, fire trucks, and other large vehicles. The width of the bridge cannot accommodate these larger vehicles. The bridge's current weight limit is 40,000 Gross and 21,000 lbs Tandem Axle.

▪ Remove and Relocate Truss span:	\$26,700
▪ Repair damaged members and corroded sections on truss members:	\$8,100
▪ Install new bridge deck:	\$37,000
▪ Install pedestrian railing:	\$16,000
▪ Clean and paint existing structure:	\$130,000
