CENTRAL TEXAS TURNPIKE PROJECT

ANNUAL INSPECTION REPORT
FISCAL YEAR 2010

PREPARED BY **PBSJ**[®]
GENERAL ENGINEERING CONSULTANT

Subject: FY 2010 Inspection of the Central Texas Turnpike Project

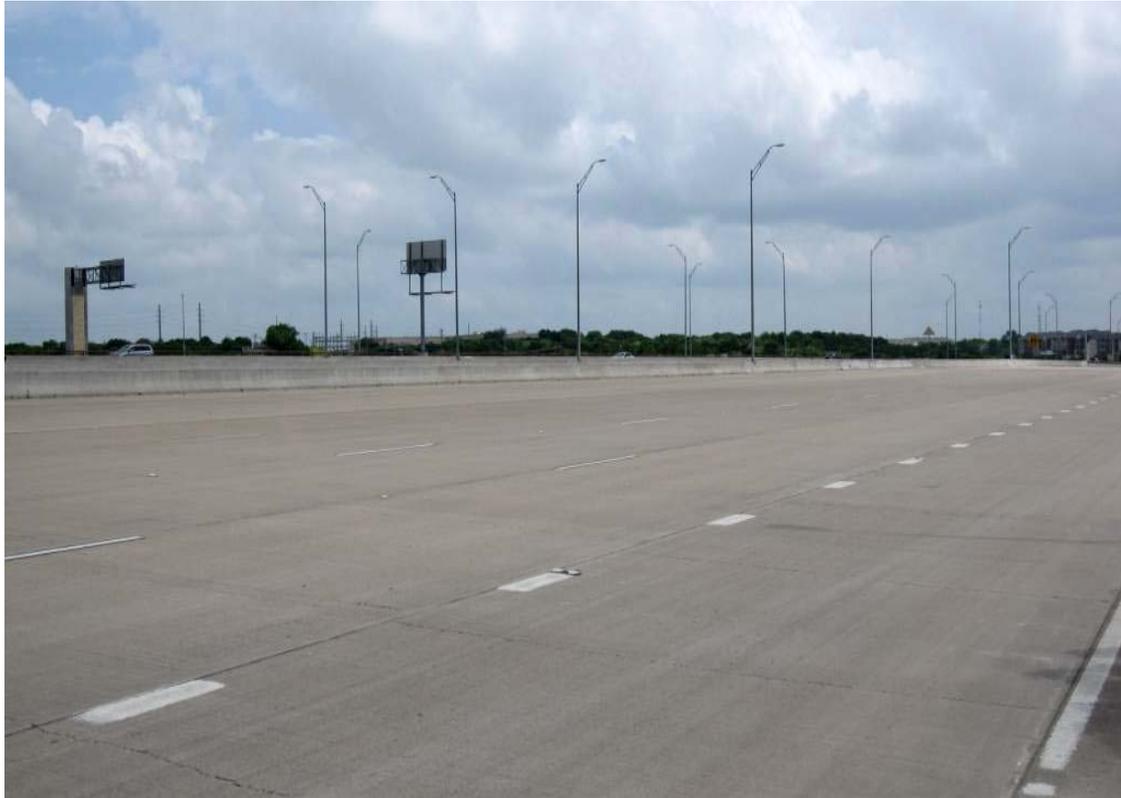
Figure 3 - Typical Roadway Section

The pavement category includes; rutting, cracking, pavement failures, ride rating, edges and shoulders. Pavement throughout the CTTTP was generally found in like new condition and achieved an overall score of 94. The lowest pavement element score, cracking, received a score of 75 and was noted on SH 45. There were no major deficiencies on any of the three roadway systems reported by the annual inspection.

TxDOT Austin District Maintenance has noted the need for the repair of pavement on the southbound approach to the ML 1 toll plaza on Loop 1. Testing and analysis is underway to determine the requirements of the repair.

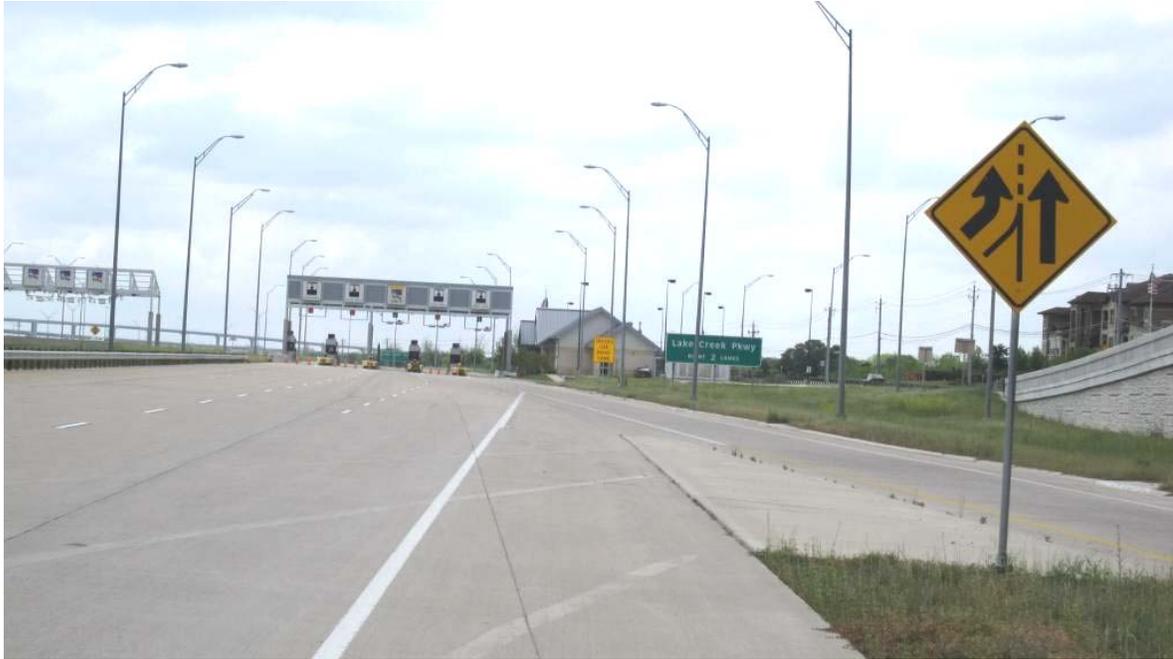
Figure 4 – Roadside Sign and Pavement Symbols

The Traffic Operations category ratings are based on the condition of all features that guide, protect, and assist the patron while traveling the Turnpike System's roadways and interchanges. A Traffic Operations score rating of 94 was achieved. No single element on any of the three roadways was found to be in less than good condition.

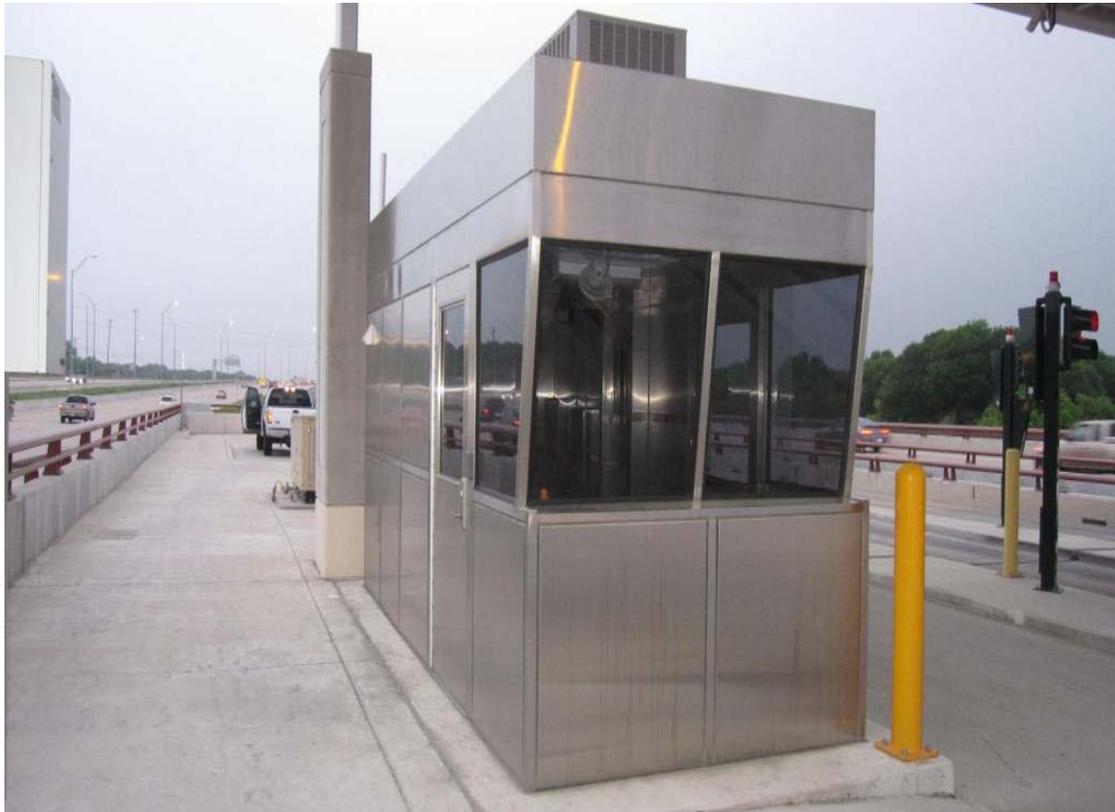
Figure 9 - Tollbooth

All tollbooths, including forty that have been decommissioned were inspected during the FY 2010 inspection. Tollbooths and related subcomponents were noted in excellent condition throughout the CTTP. Only one tollbooth element, Toll A/C at 9.24% was rated deficient within the system. It was noted that 8 of the 9 tollbooth AC's found deficient were in booths that have been taken out of service. A typical tollbooth configuration is pictured below in Figure 9. The condition of the elements and the corresponding deficiencies for each of these categories is summarized in Tables 9 through 11, with a system-wide summary shown in Table 12.

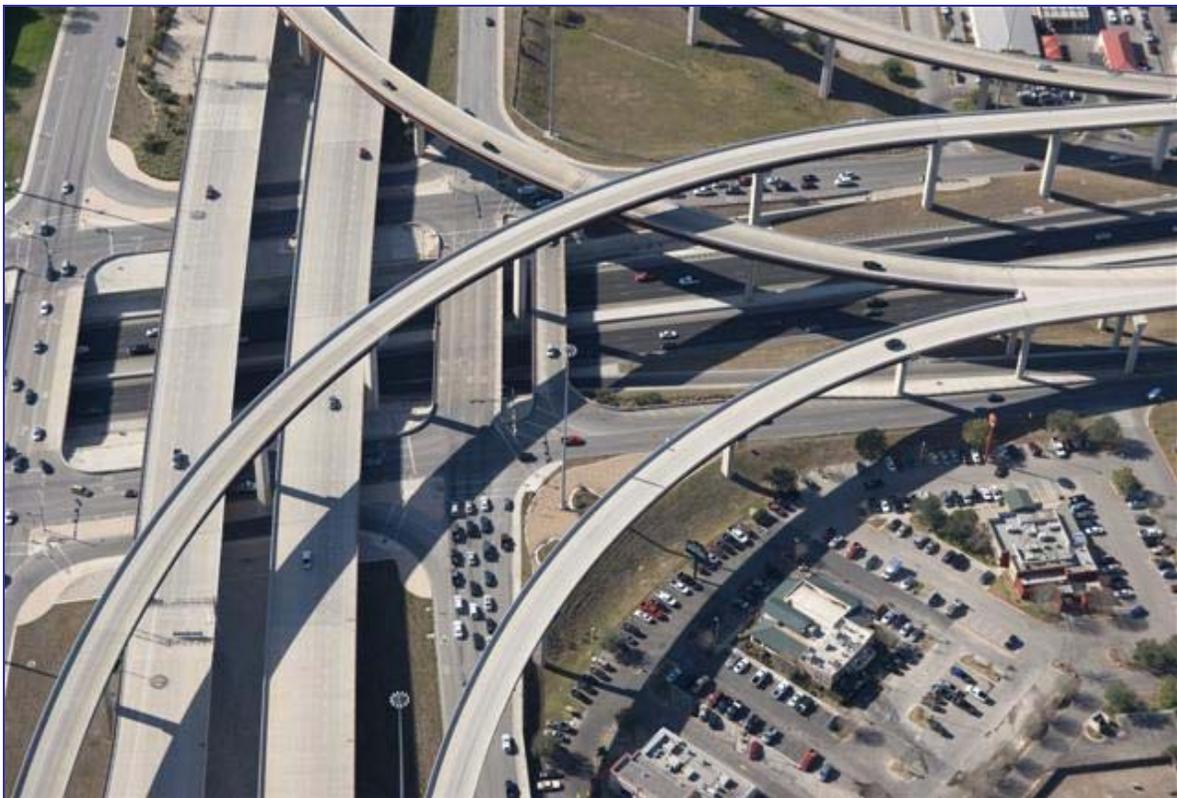
Figure 11 - Bridges

The Federal Bridge Inspection Summary Report (Appendix C) was compiled, reviewed, and is included on the CD located in the CD jacket inside the back cover of this report. The bridge components and major elements are listed in Table 14. The biennial inspection is based on three main components, comprised of a total of 93 elements and 117 sub-elements for fixed bridges only. A numerical score is generated for each component based on the rating scale shown in Table 15. At the time this report was prepared, 132 of the 210 bridges within the CTPP had been inspected since last year's report. Based on conversations with TxDOT, the remaining 78 bridges are currently under inspection and the results will be available for next year's Annual Inspection Report. A review of the Federal Bridge Inspection Summary Report found no major deficiencies on any bridge within the CTPP. Of the 210 bridges within the CTPP only 3 (1.4%) had a rating in any category as low as 6 (Satisfactory). The remainder of the ratings were all in the 7 to 9 range (Good to Excellent).
