# CENTRAL TEXAS TURNPIKE SYSTEM 2002 PROJECT

ANNUAL INSPECTION REPORT  
FISCAL YEAR 2011

Subject: FY 2011 Inspection of the Central Texas Turnpike System, 2002 Project

**Annual Inspection Report**  
For the fiscal Year ending August 31, 2011

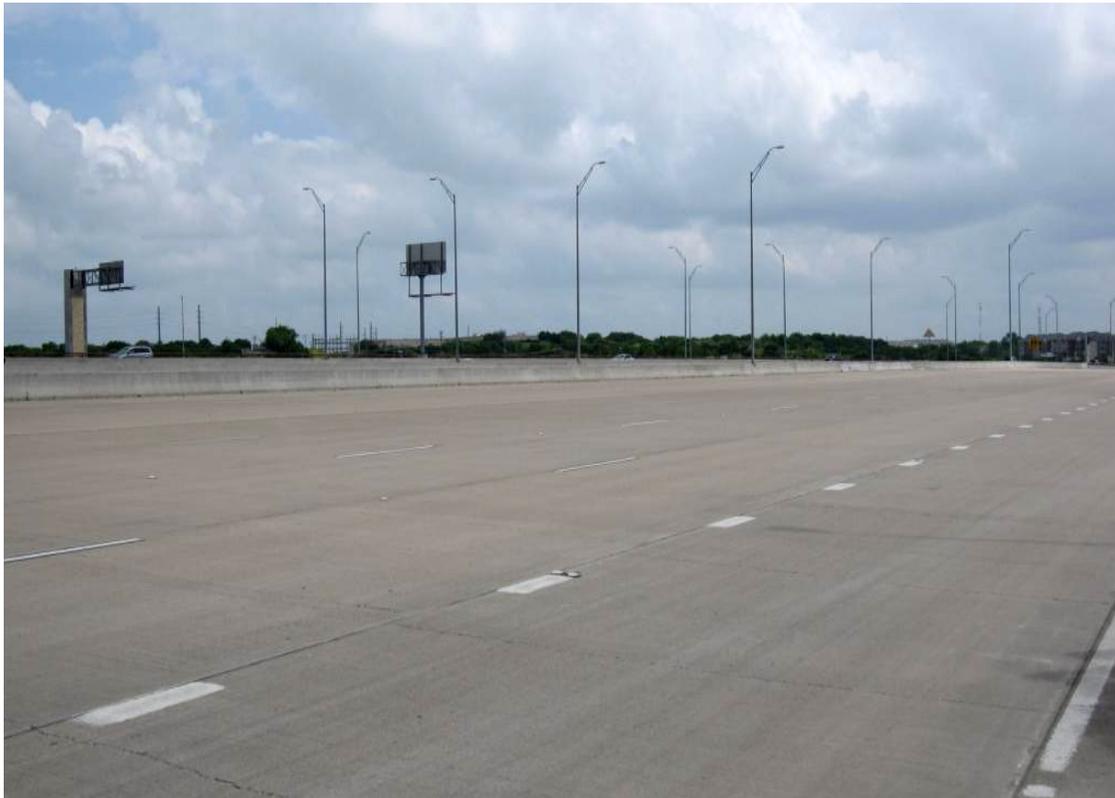
**Figure 3 - Typical Roadway Section**

The pavement category includes; rutting, cracking, pavement failures, ride rating, edges and shoulders. Pavement throughout the CTTS was generally found in like new condition and achieved an overall score of 95. The lowest pavement element score, cracking, received a score of 75 and was noted on Loop 1. There were no major deficiencies on any of the three roadway systems reported by the annual inspection.
