Sta. 175+34 - 180+04
 3 Span Continuous Steel Unit on Concrete Pipes & 6 Simple Reinforced Concrete Pan Girder Spans On Steel Pile bents

FM 1476 @ LEON RIVER
 230470103902014
 COMANCHE CO.

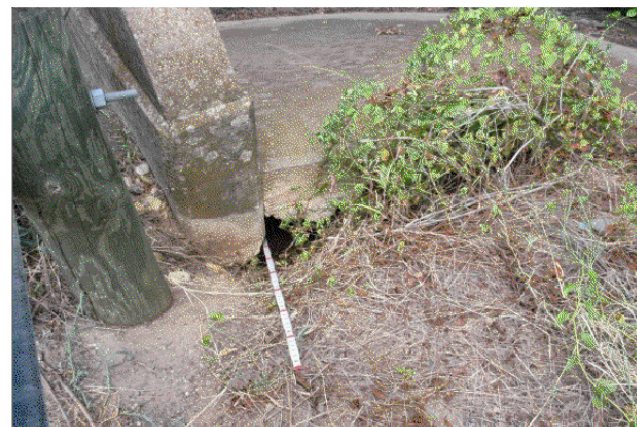
PHOTO #1

Note: Embankment erosion has undermined top of concrete riprap at SE corner approx. 3'.

UNDERMINING RIPRAP SE CORNER
 Looking N
 IMG. 0704

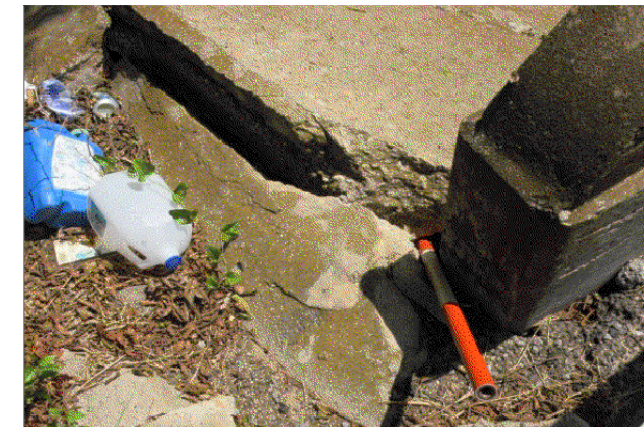
PHOTO #2

Note: Embankment erosion has undermined top of concrete riprap at NE corner approx. 2', causing the top corner of riprap to break away.

UNDERMINING RIPRAP NE CORNER
 Looking SE
 IMG. 0700
